Hydro-Vulnerability Assessment

For Native Village of Venetie Tribal Government, including Venetie and Arctic Village

September 2021

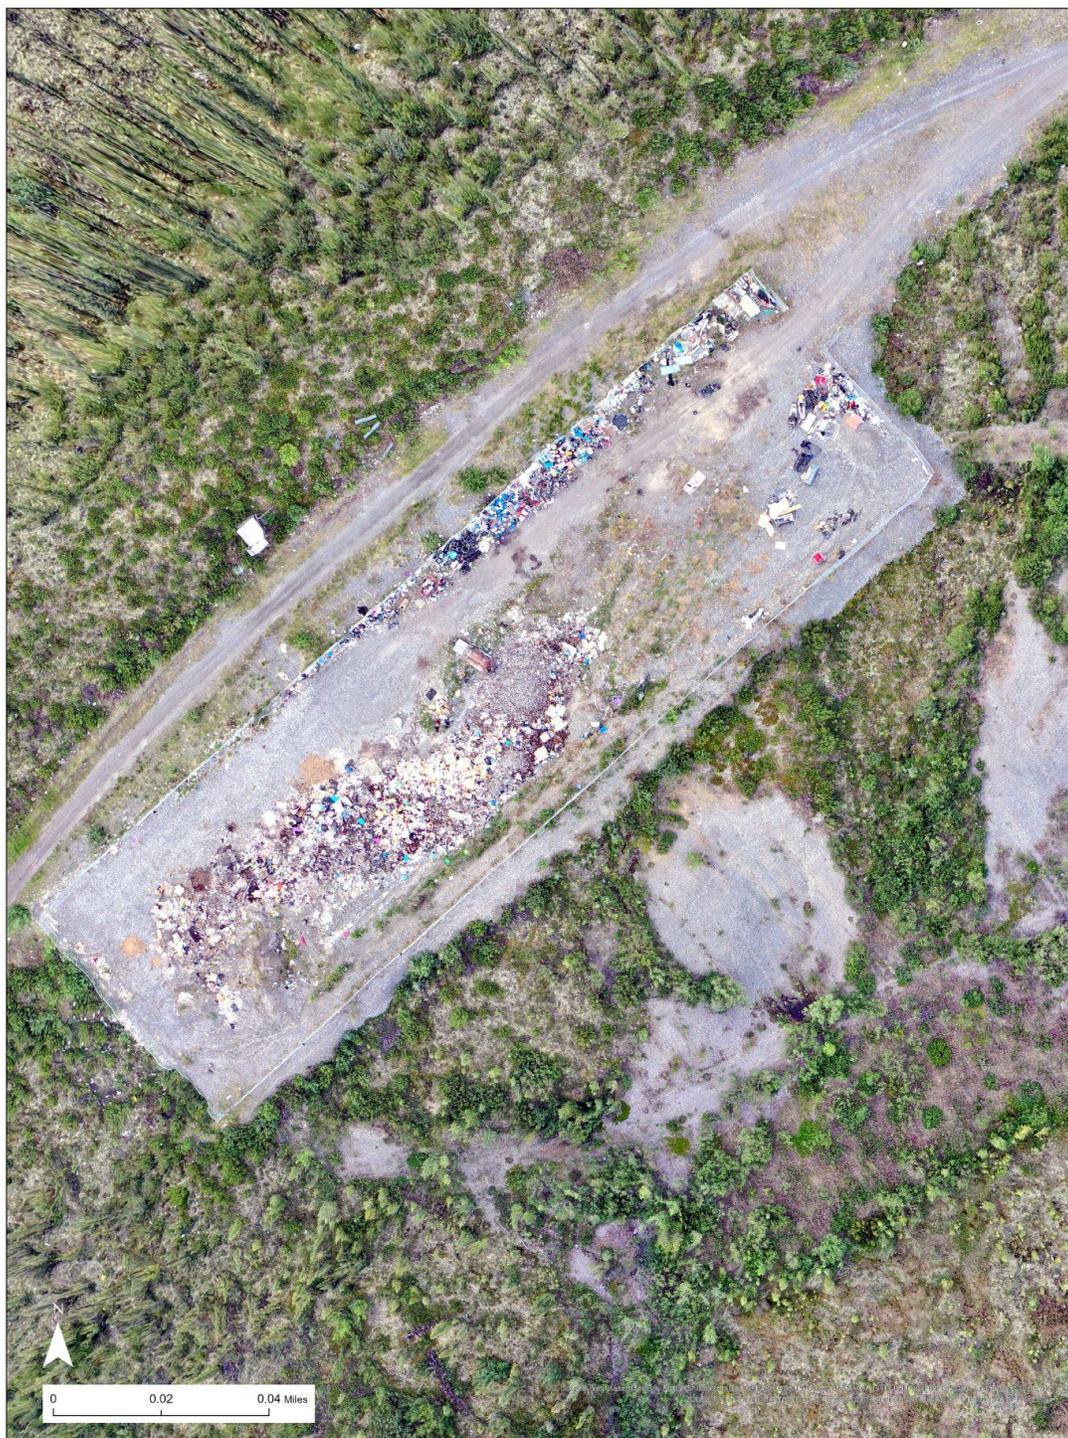
Figure 1. Aerial of landfill in Arctic Village.

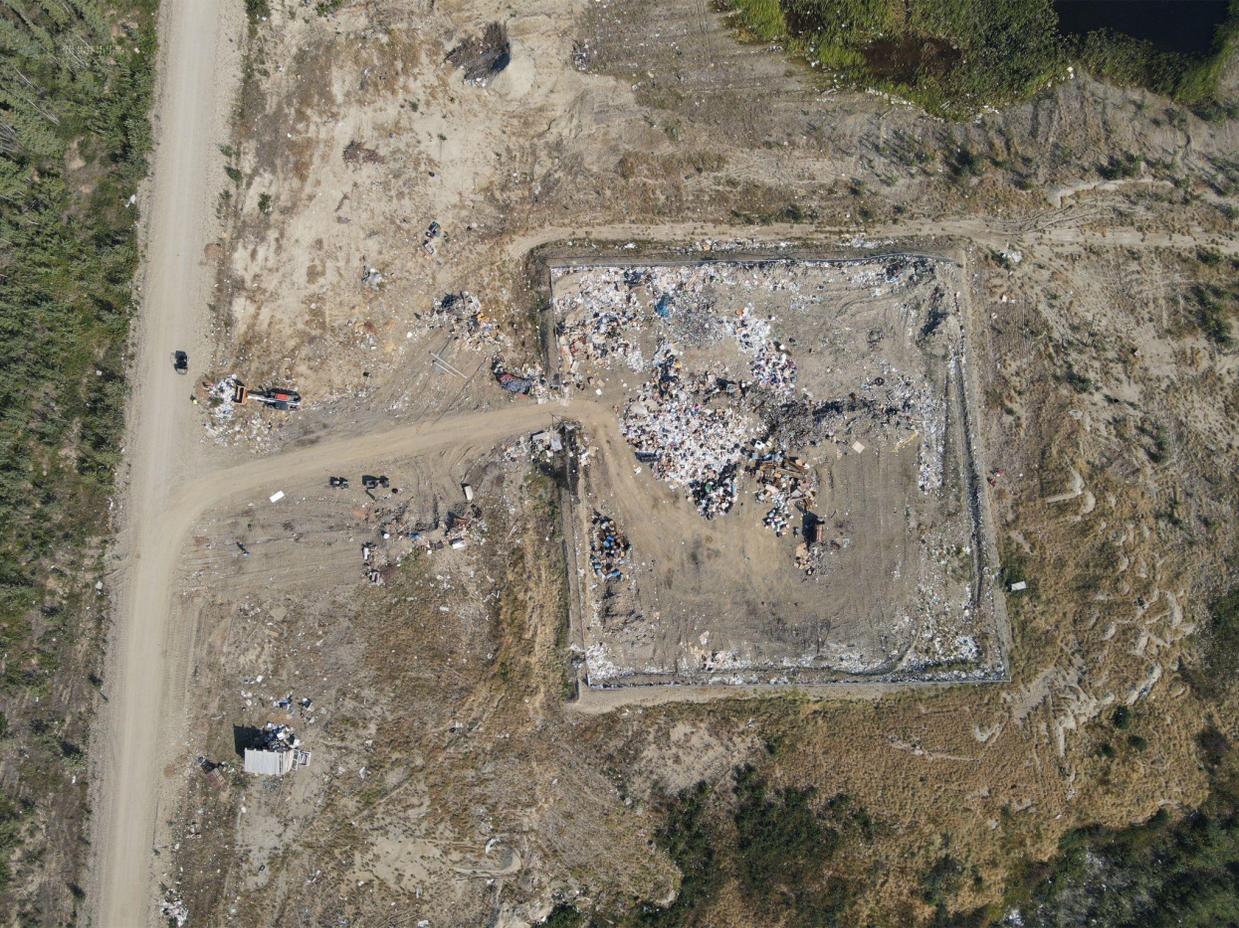
Figure 2. An aerial of the Venetie landfill.

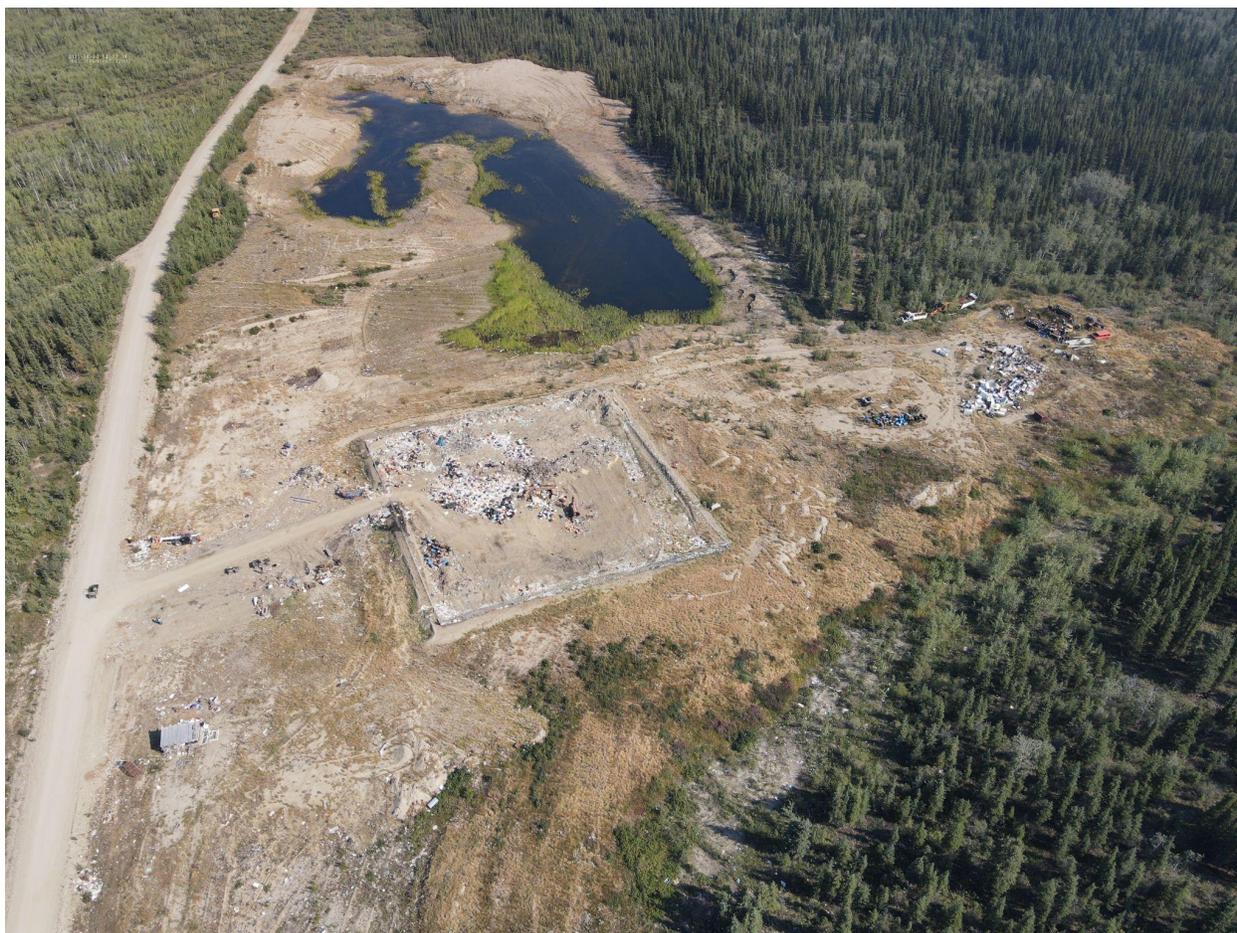
Aerial photos were taken of the Arctic Village (figure 1) and the Venetie (figures 2 - 3) landfills. The images can be used in community outreach, to guide community-members where to dump, or to help the landfill manager. The waters shown in figure 3 have been sampled by YRITWC and the NVVTG Environmental Department.

Figure 3. Venetie landfill zoomed out view, showing waters where sampling has occurred.

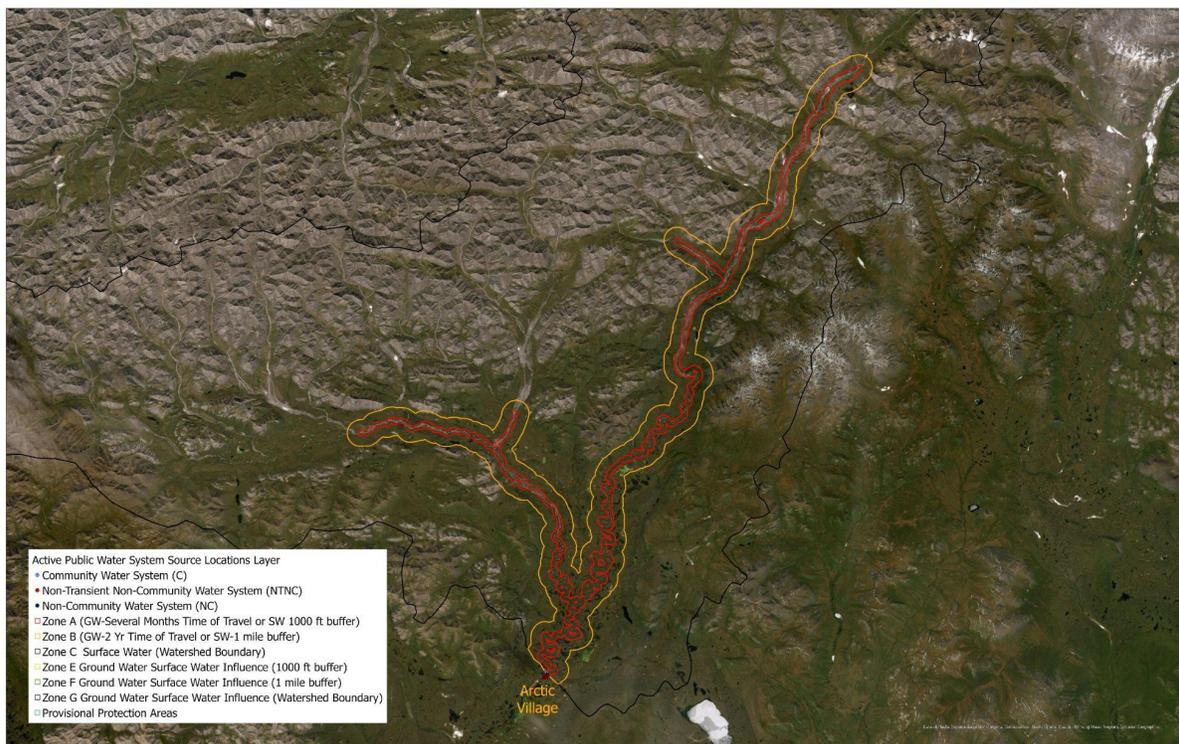
Figure 4 shows the drinking water protection zones for Arctic Village. The water is taken from surface water, which means that drinking water is under the direct influence of surface water. The yellow line is the 1 mile buffer around surface waters, and the red is the 1000 foot buffer. The protection of these areas from contaminants is encouraged by the US Environmental Protection Agency and State of Alaska.

Figure 4. Overview of sewage lagoon, community drinking water source and drinking water protection zone.

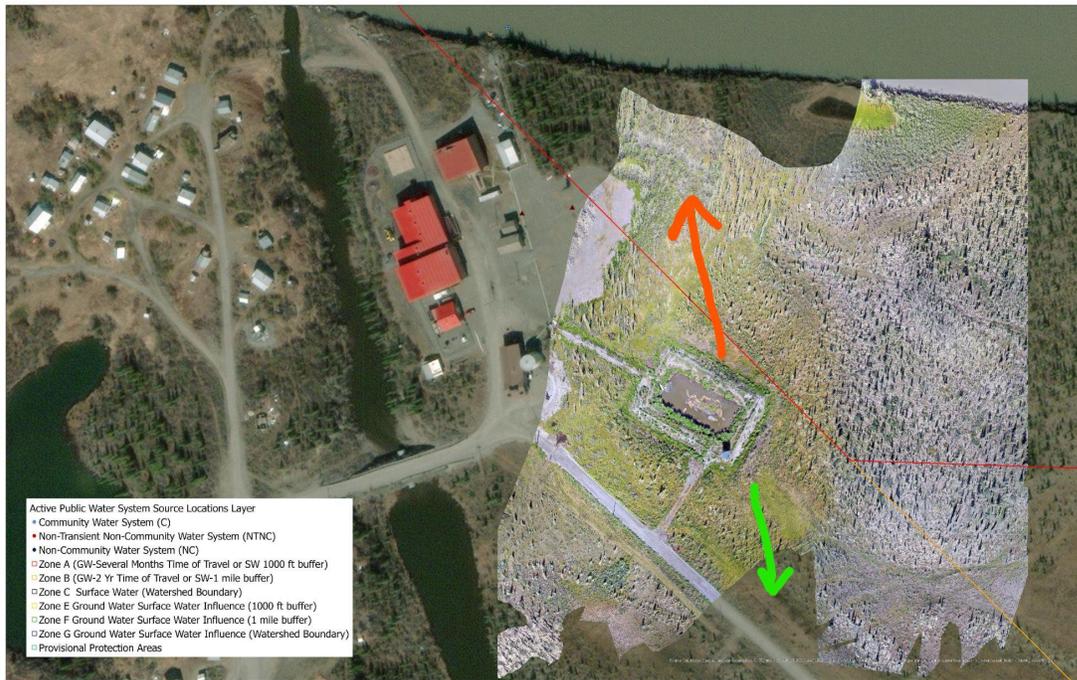
The sewage lagoon was built just outside of the buffers of source water protection areas (see figure 5). The tiny blue dot just northeast of the school is the drinking water intake for the washerteria, and the school. The concern is that the lagoon is draining following the red arrow in figure 5, instead of away from the community as shown with the green arrow. Figure 6 is an elevation map, where blue are low areas, and red are areas of higher elevation. From this map it is clear that surface water flow is draining to the south, because of the topography of the area. Although, it is difficult to know the direction of groundwater flow.

Figure 5. The sewage lagoon (mapped using an UAS) and the boundaries of the buffers for the drinking water protection zones.

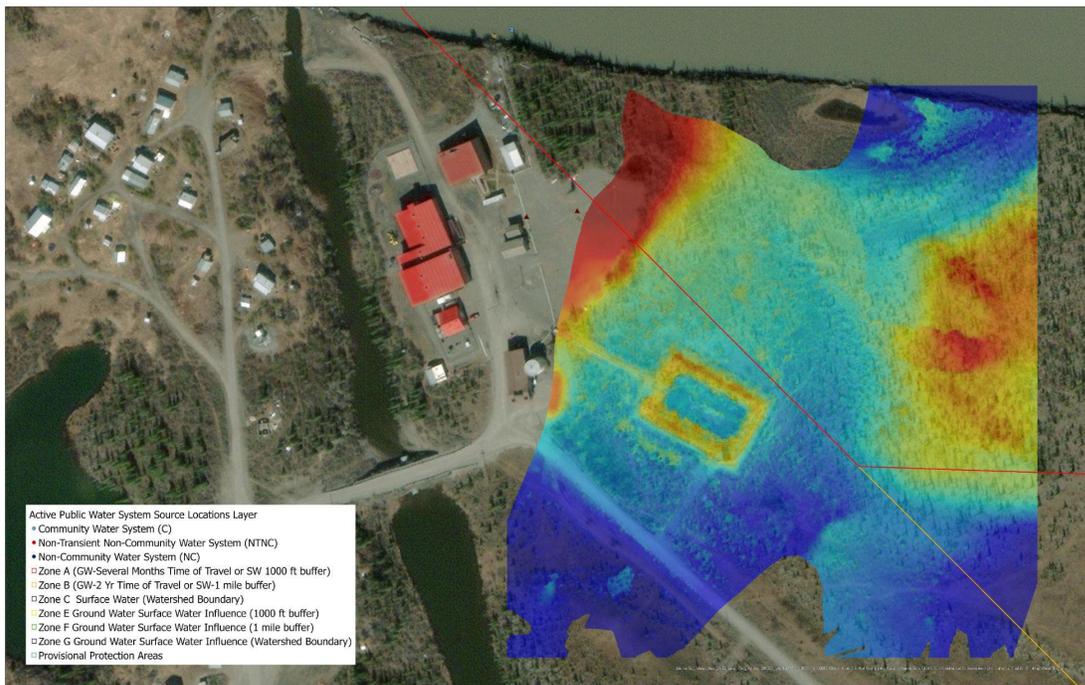
Figure 6. Elevation map where blue is low and red is high.

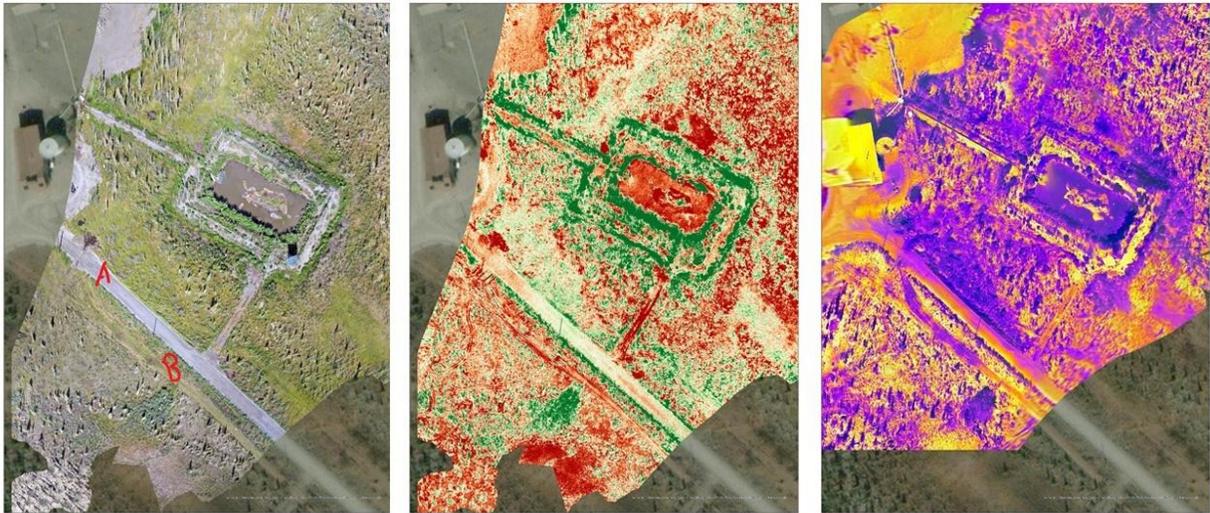
The panel of maps in figure 7 includes a thermal map and a NDVI vegetative health map, with a little more information. It looks like there are two places that are draining surface waters, which are marked

on the first map as 'A' and 'B'. In the aerial view a wet area can be seen at 'A', and what looks like a culvert that runs under the road. An additional drainage can be seen in the NDVI vegetation health map. This map displays photosynthetic activity, where dark green areas are healthy plants and red is dead. Interestingly, a plume of green can be seen at area 'B' indicating good growing conditions such as moisture and nutrients. Phosphorus and nitrogen from sewage lagoons can act as fertilizers and create good growing conditions. The third panel in figure 5 is further evidence of these two draining areas. This map is a thermal image, where purple indicates cool areas and yellow are warm areas. These images were taken on July 8, 2021 at about 2:15 pm. It was a warm day, so the cool areas are likely wetter areas as water takes longer to warm than dry ground. Both areas 'A' and 'B' are cooler wet areas, where there is likely some drainage. These don't necessarily pose a human health risk, especially if the natural filtration is working as designed, but it is something to keep an eye on, especially if there are other indicators of contamination, such as smell and/or contamination found in drinking water.

Figure 7. From left to right 1.) close-up aerial view 2.) NDVI vegetative health index 3.) thermal image

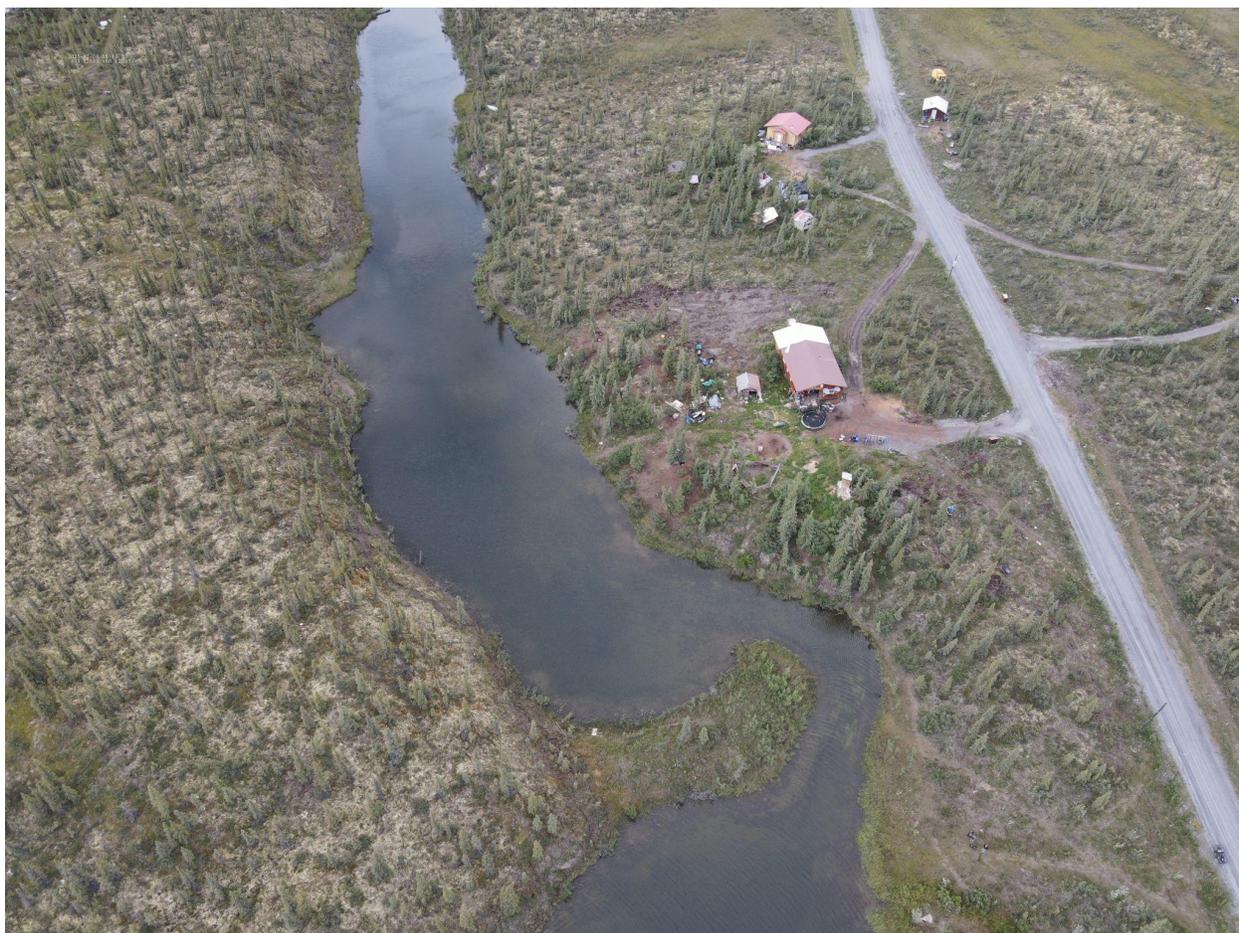
Figure 8. Documentation of an additional erosion concern near residential areas in Arctic Village.

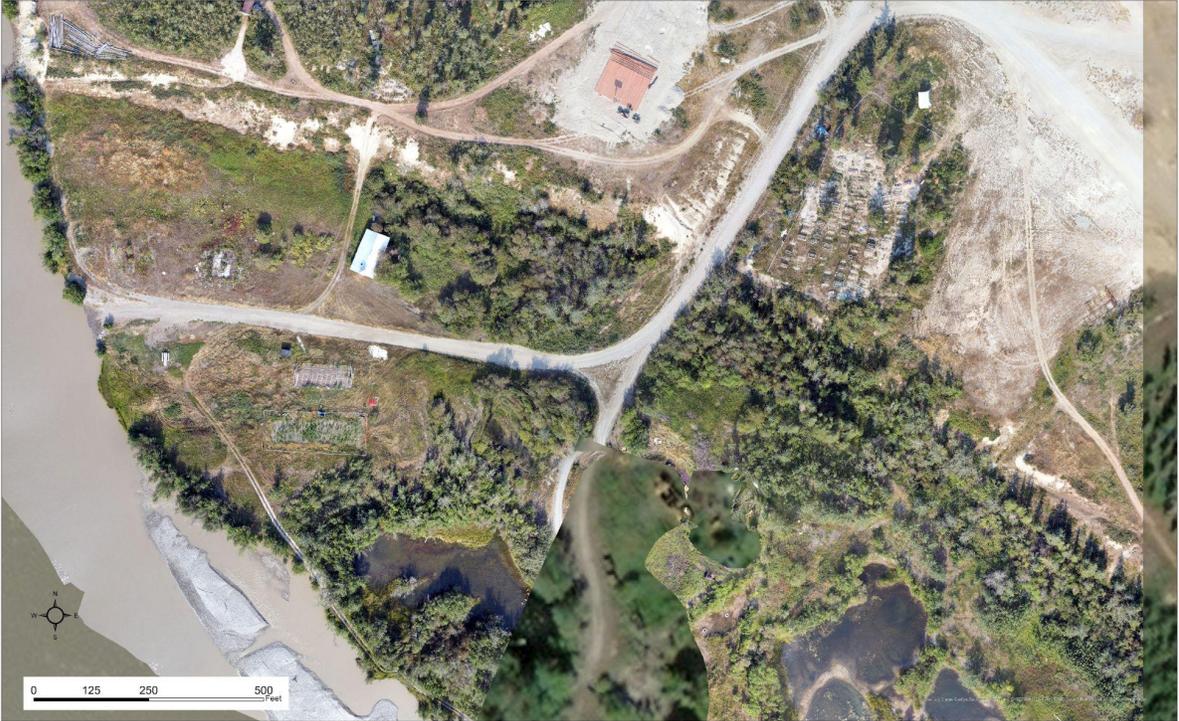
Figure 9. Documentation of erosion in Venetie.

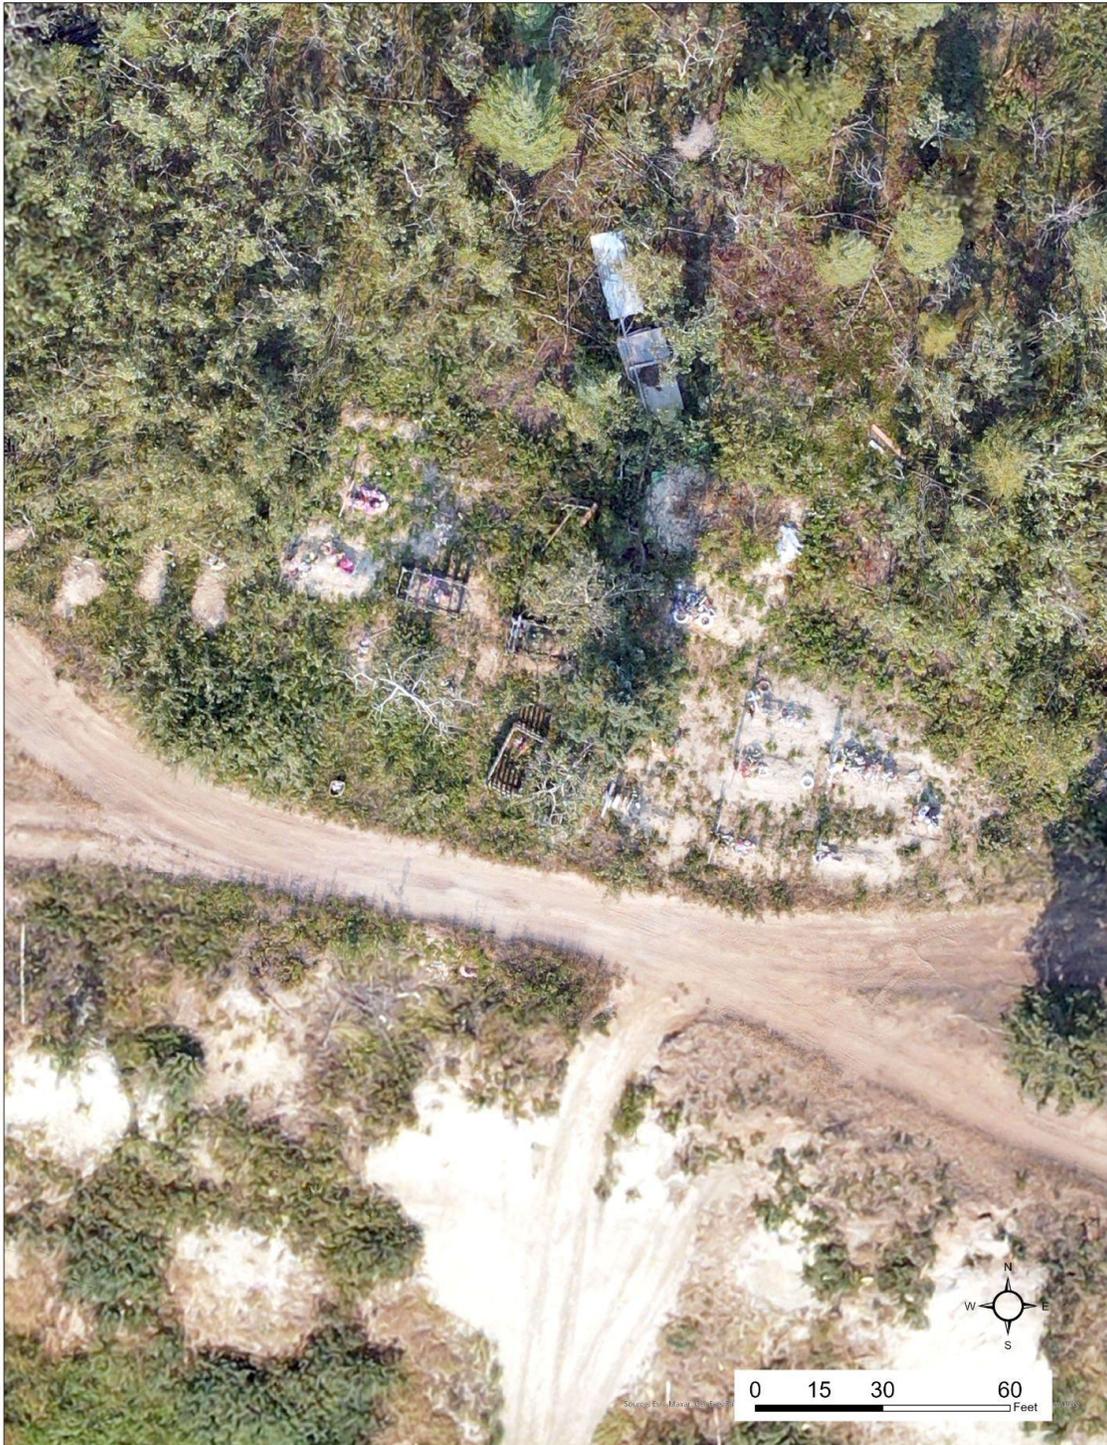
Figure 10. Close up of west cemetery in Venetie, which are of particular concern for erosion.

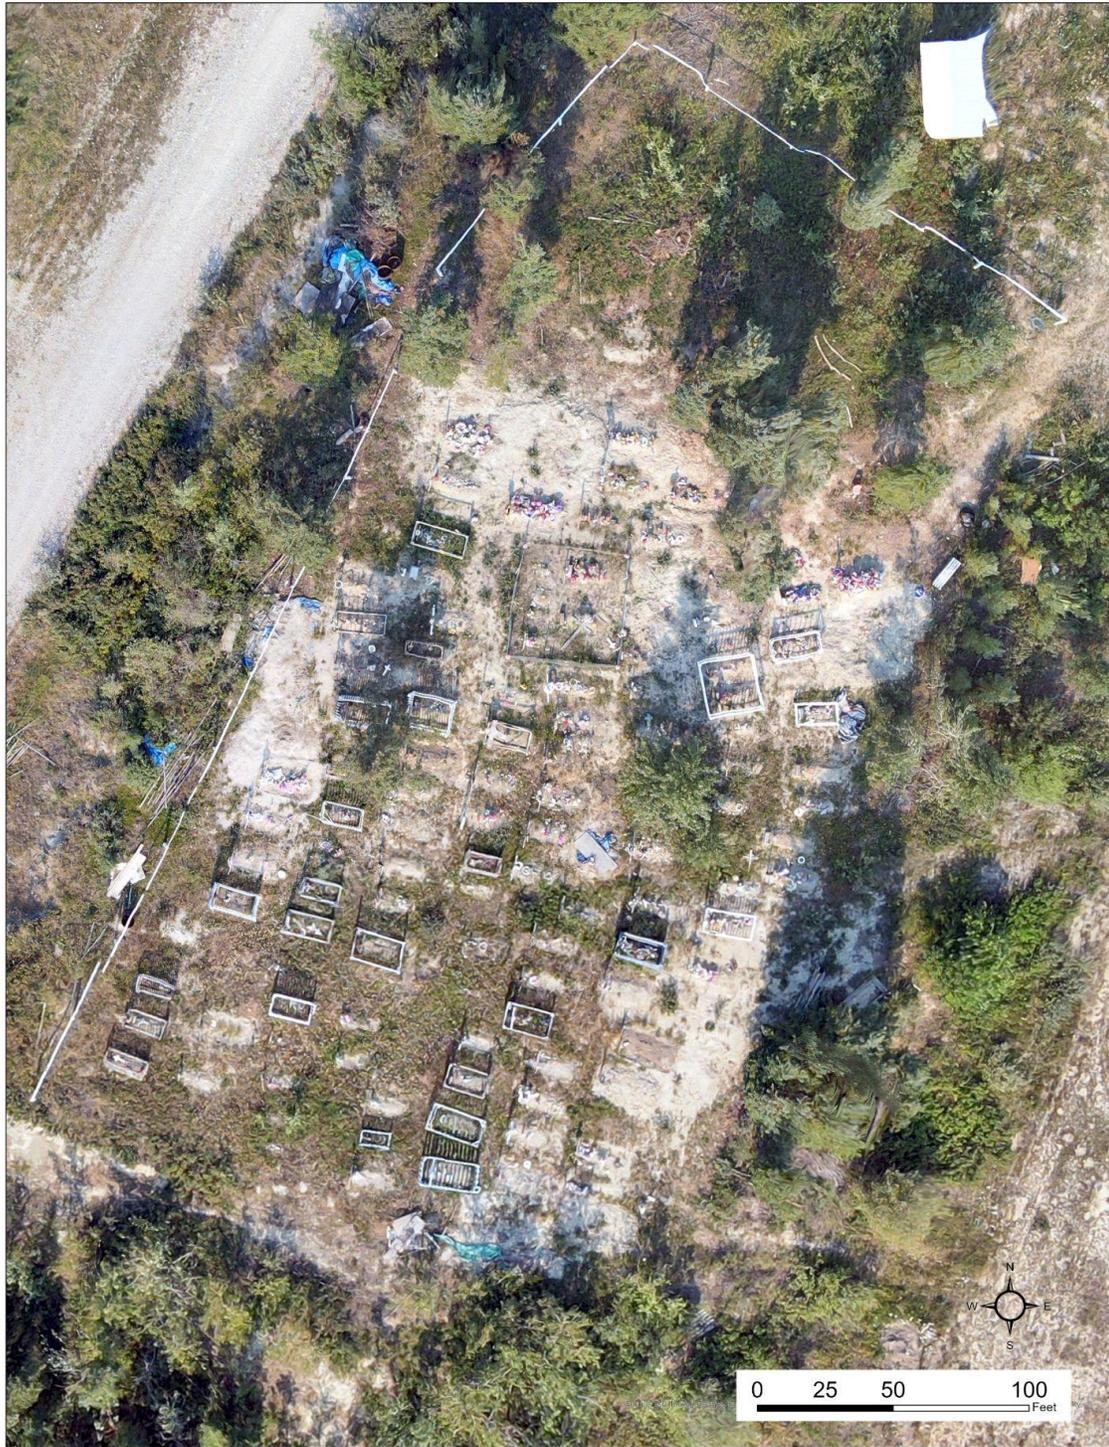
Figure 11. Close up of the east cemetery in Venetie.

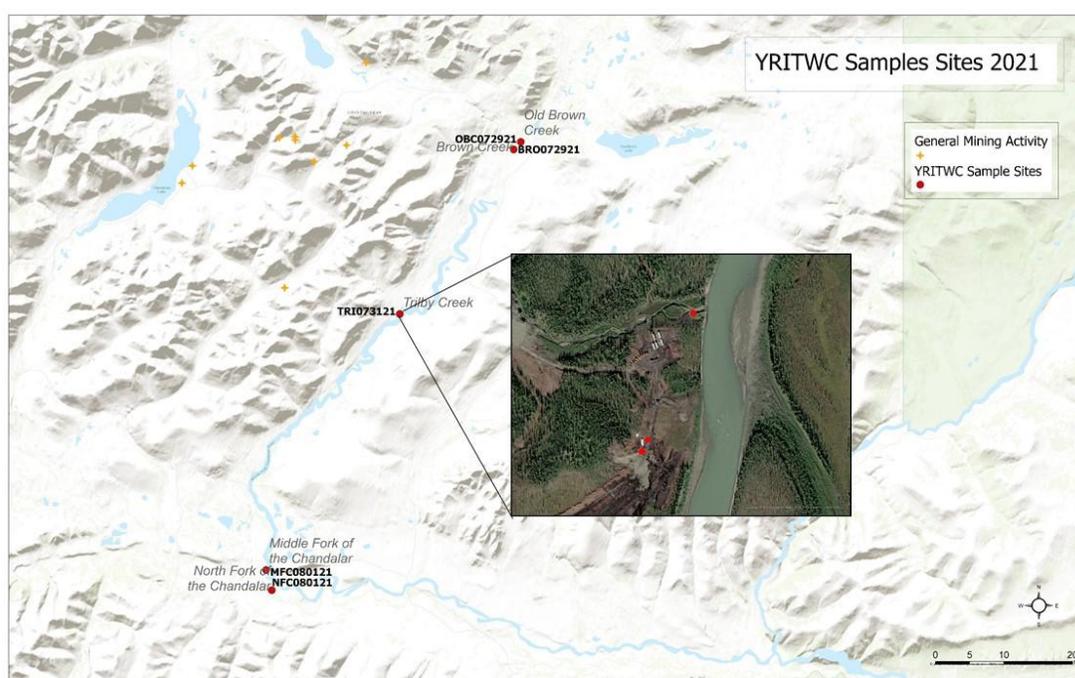
Figure 12. Sample sites.

Overall waters and sediment were found to be very clean. Sample results were compared to the Drinking Water Standards, and the standards for continued exposure for freshwater aquatic life from the AK DEC. The only samples that exceeded either of these was the pH of 8.5 in the Middle Fork of the Chandalar, which is at the limit for drinking water, and Mercury was found in Brown Creek that exceeded the standard for freshwater aquatic life.

The mercury found in Brown Creek was at 1.17 parts per billion (ppb). The limit for chronic exposure to freshwater aquatic life is set at 0.1 ppb. This means the mercury present in the creek is likely impacting any aquatic life there, including fish. Very low levels of DRO and RRO were found in Brown Creek, Trilby Creek, the North Fork of the Chandalar, and the Middle Fork of the Chandalar. The highest of these was the RRO in Trilby Creek at 176 mg/kg when the maximum presence allowed by the State of Alaska before a site is considered cleaned-up is 22,000 mg/kg. These low levels are unlikely to have impacts. Similarly, very low levels of Gasoline Range Organics were found near the fuel tank, and are unlikely to have any negative impacts.

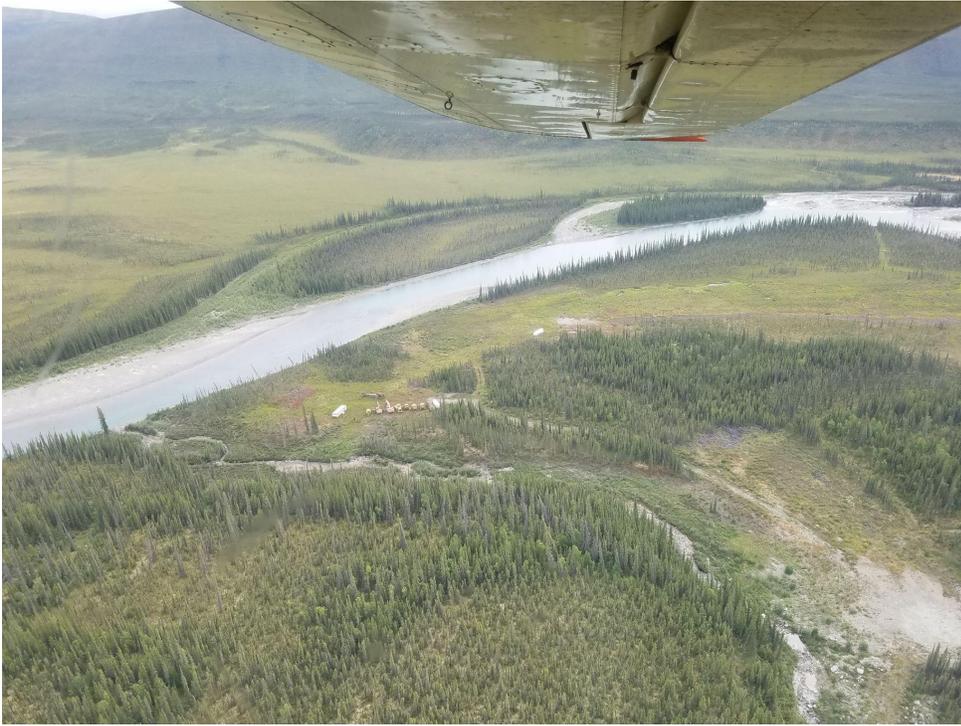
There is a significant camp at Trilby Creek that supports mining activity. It includes seven pieces of heavy equipment, two very large fuel tanks, a trailer, and two other pieces of large mining equipment. There are also batteries, many 55 gallon drums, generators and other mine related equipment (see figures 13-17). All fuel tanks and 55 gallon barrels seem to be empty, based on thermal imagery and a hollow sound when knocked on, although they could have residual fuel in them. A bear has been digging around the large fuel tank near the airstrip, likely attracted by the smell of fuel, or the creosote treated foundation it is built on. Samples found little evidence of fuels in the soil here.

Figure 13. Aerial overview from the airplane of the gold mine camp.

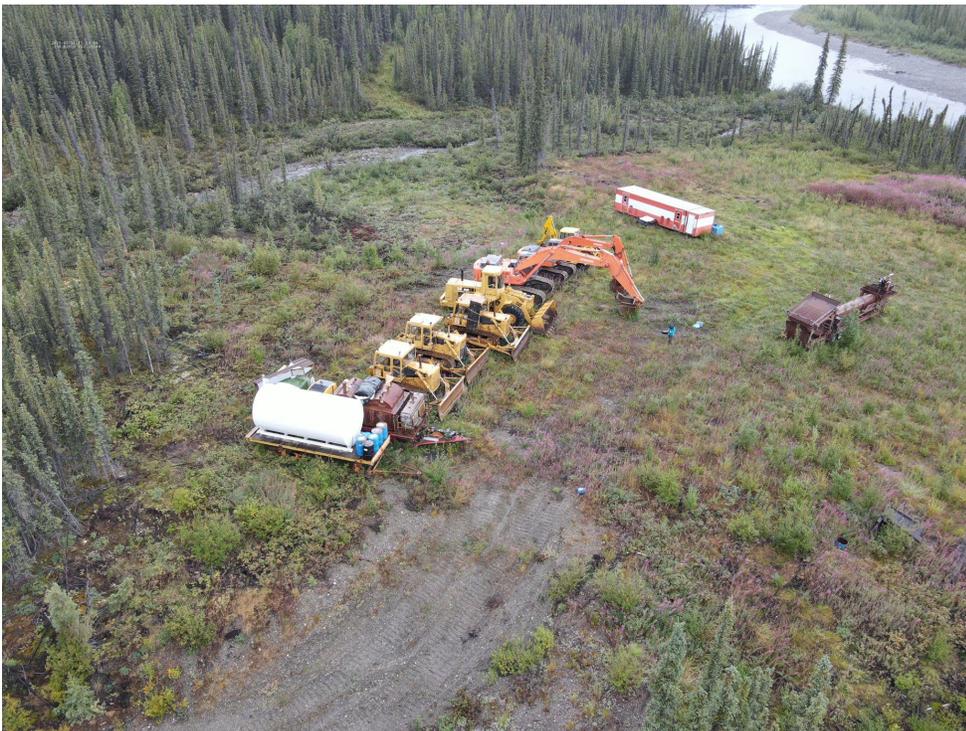
Figure 14. Heavy equipment, fuel tanks and other equipment.

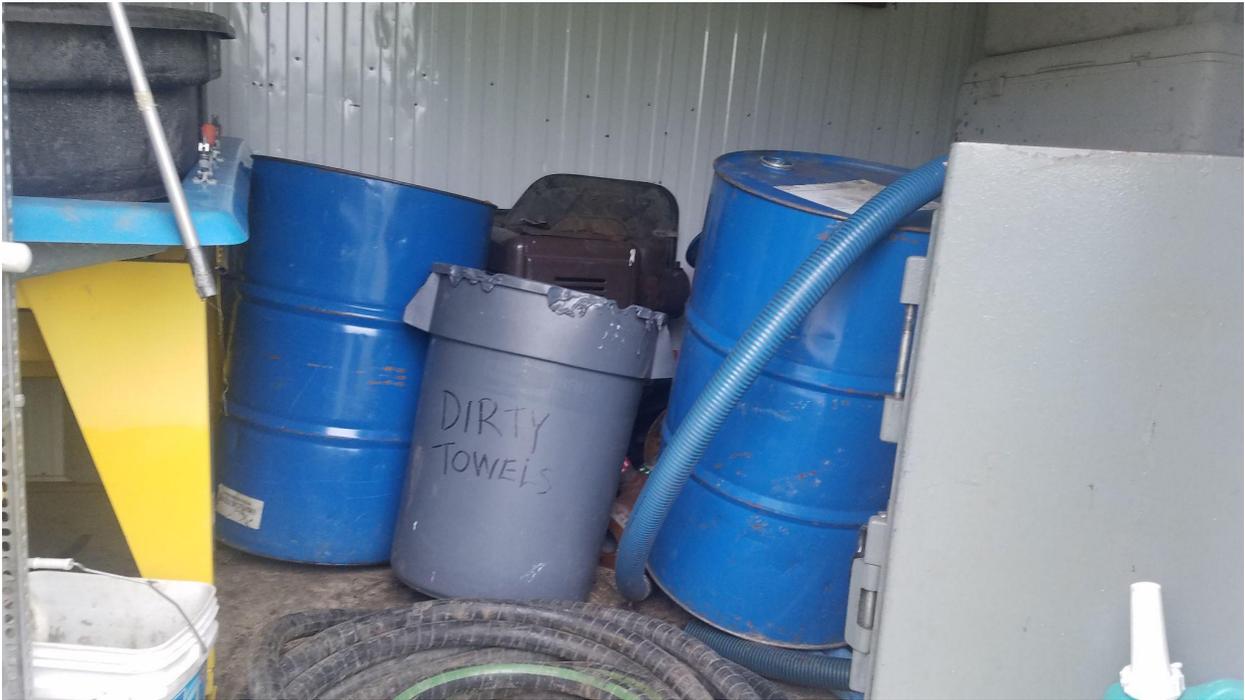
Figure 15. Looking inside the trailer.

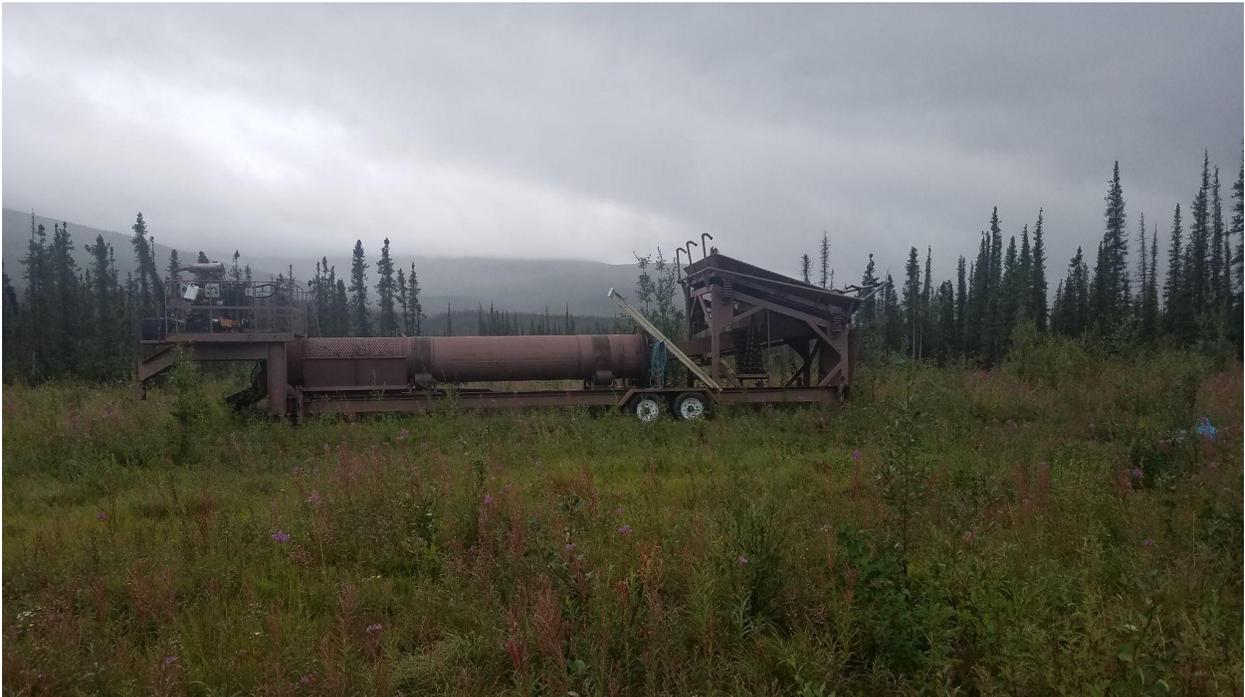
Figure 16. Centrifuge for separating the gold.

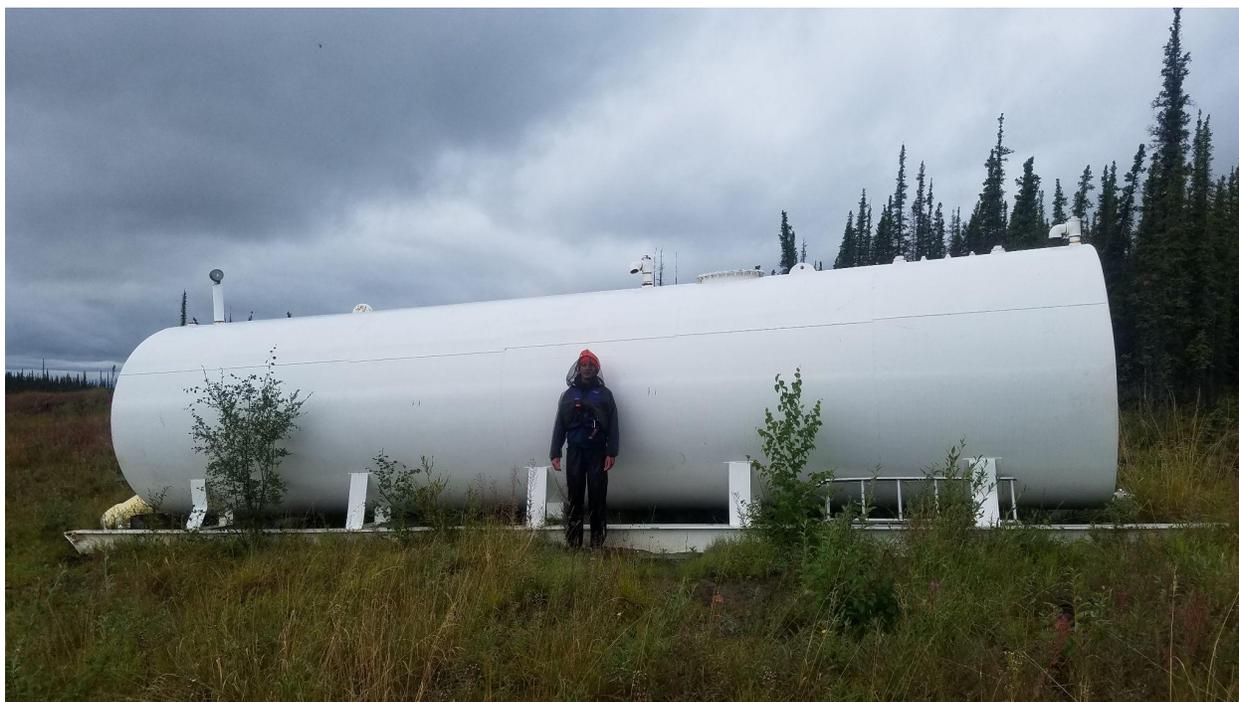
Figure 17. Large fuel tank near the airstrip.

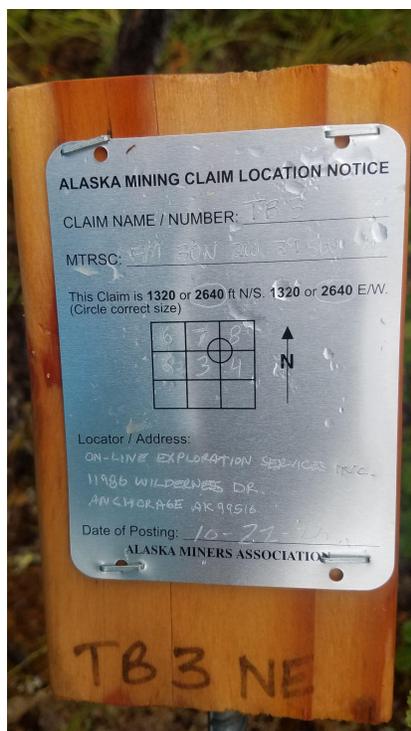
Online Exploration recently owned this mine claim (figure 18), although through a search of the State of Alaska's DNR land records, and the Alaska Mapper it was found that the lease was transferred to Atom Gold Alaska Corporation in 2021. During a phone conversation on March 18, 2021 with Kevin Adler the previous operator at OnLine Exporation (olexplor@alaska.net, 907- 345-4815) he explained that they planned to work during the 2021 summer season. Online Exploration purchased the equipment staged at Trilby, from the previous operators Goldrich Mining Company, and planned to either reccomision them for use, or backhaul them. They were planning to do exploratory work on Trilby and Big Creek, with some drilling, Ground Penetrating Radar, and perhaps limited suction dredging. If they found enough gold to make the expense worth it, they planned to raise funds and develop a larger placer gold mine, basically digging through old river beds, crushing and washing rocks. This could be at Big Creek, Trilby Creek or both. We were at the site on July 31, 2021, and there were no signs of recent activity. The plans of Atom Gold are unknown. This site has been added to YRITWC's Brownfields inventory, which means we will continue to monitor the site, and if the equipment becomes abandoned, we will look for the responsible party and work to hold them accountable to get the site cleaned-up. Appendix 2. includes the summary of this site for including it in the YRITWC's Brownfield inventory. Given its remoteness, it would be a significant effort and cost to clean this area up.

Figure 18. Posted at site
