Hydro-Vulnerability Assessment

Chevak, Alaska

September 2021

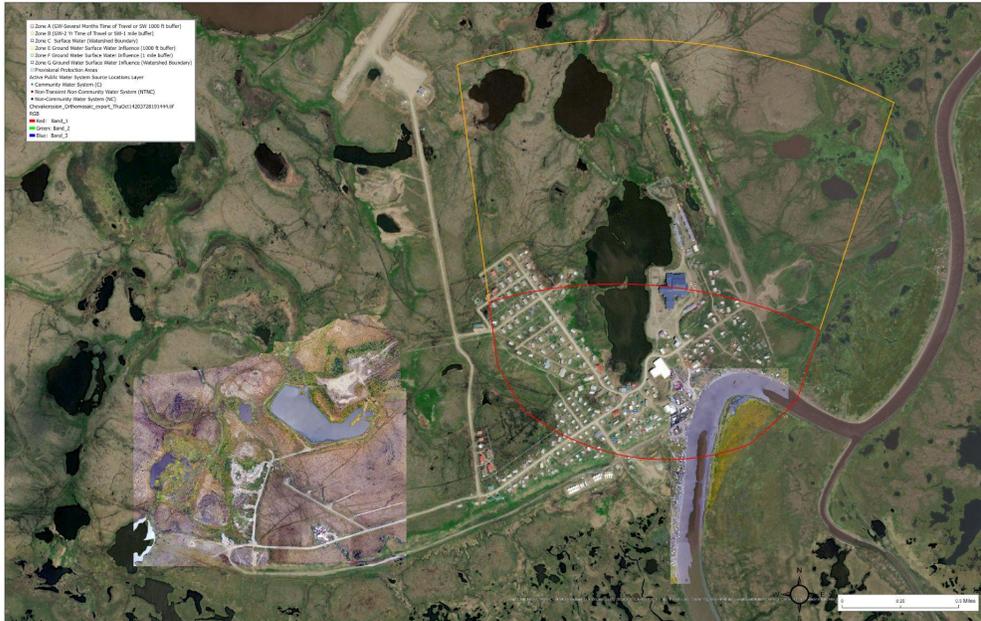
Figure 1 includes the area flow with a UAS, and community drinking water sources and drinking water protection zones from AK DEC. Community drinking water is classified as 'Groundwater – System has a groundwater source that is not under the direct influence of surface water (e.g., protected wells) and no surface water or groundwater under the influence of surface water sources.' Drinking water protection zones are also shown. The red line shows 'several month time of travel' meaning it would take waters in this zone several months to reach the community intake of groundwater. The orange line shows '2 year time of travel', so surface waters in this zone would take 2 years to reach the water intake.

Figure 1. Overview of landfill, community drinking water source and drinking water protection zone.

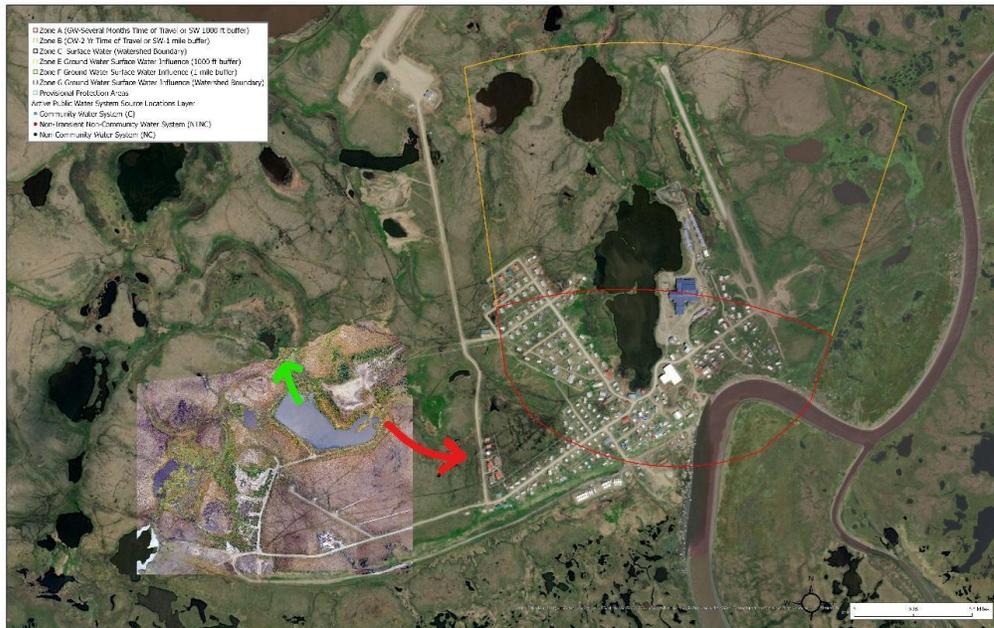
A concern was identified by tribal leadership about the drainage of the lagoon reaching the community, or community drinking water. Figure 2 shows that if the lagoon is draining toward the community, or the drinking water source, it could be a potential hazard to human health. In order to investigate this concern we first looked at the elevation map from the UAS imagery, and overlaid it with a lower resolution digital elevation model found in ArcGIS's Living Atlas (see figure 3). It confirmed that there are two low spots that could be potential drainages.

Figure 2. The concern is that the lagoon is draining following the red arrow, instead of away from the community as shown with the green arrow.

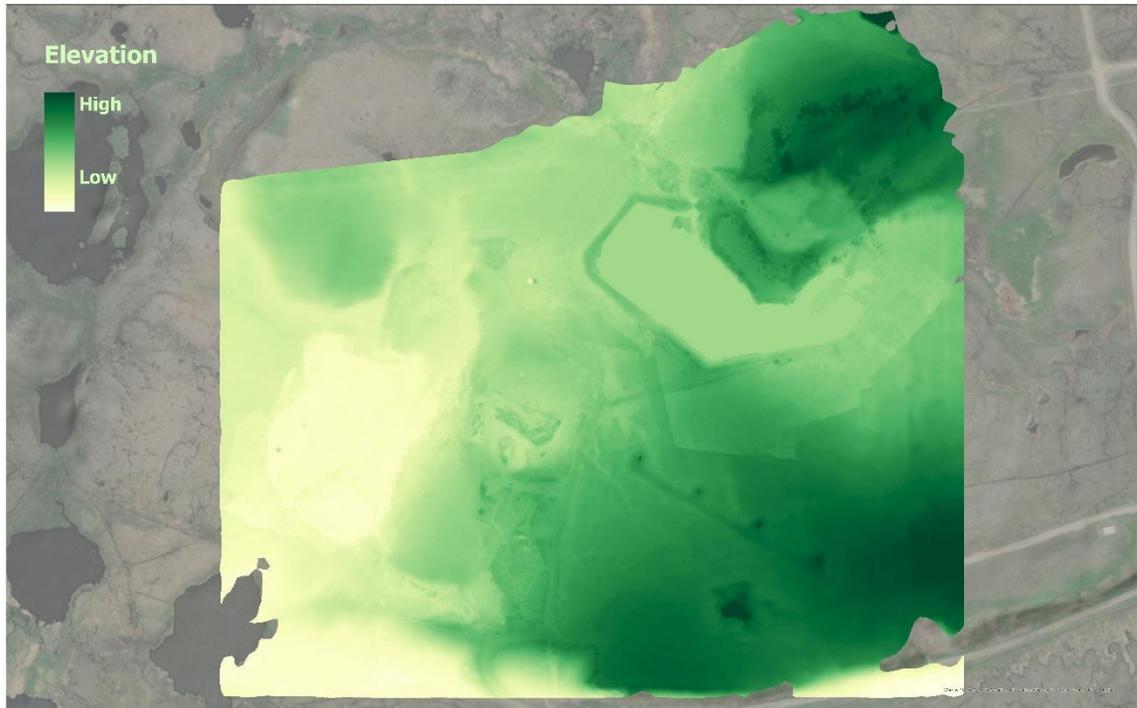
Figure 3. Elevation map.

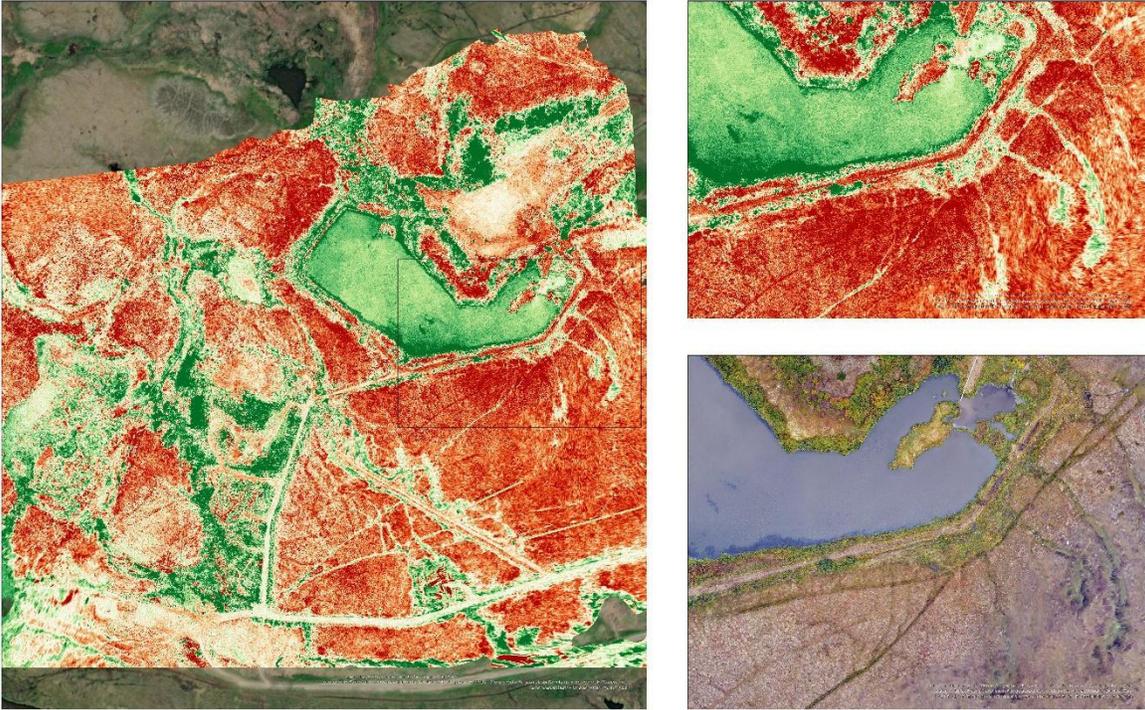
In figure 5 red indicates unhealthy or dead vegetation (red is dead) while darker green denotes photosynthetic activity and healthy vibrant plants. Plants need nitrogen, phosphorus and potassium to grow. Sewage lagoons are rich in nitrogen and phosphorus (similar to fertilizers). So more sewage will cause plants to be greener. The two map panels on the right are a close up of the area of concern. There

are four main 'fingers' where plants are very healthy. In addition, from the aerial imagery and from on-the-ground investigations, we can see these areas are wet. This provides more evidence that the lagoon is leaking out of the eastern side.

Based on these maps it does seem likely that the lagoon is at least partially draining to the east toward a natural lagoon that is surrounded by residential houses. It is difficult to know the extent of the drainage, and potential hazards without additional studies, but this is a potential hazard, especially during flooding events. Further investigation, and examination by an expert is warranted.

Figure 5. Vegetation stress map.

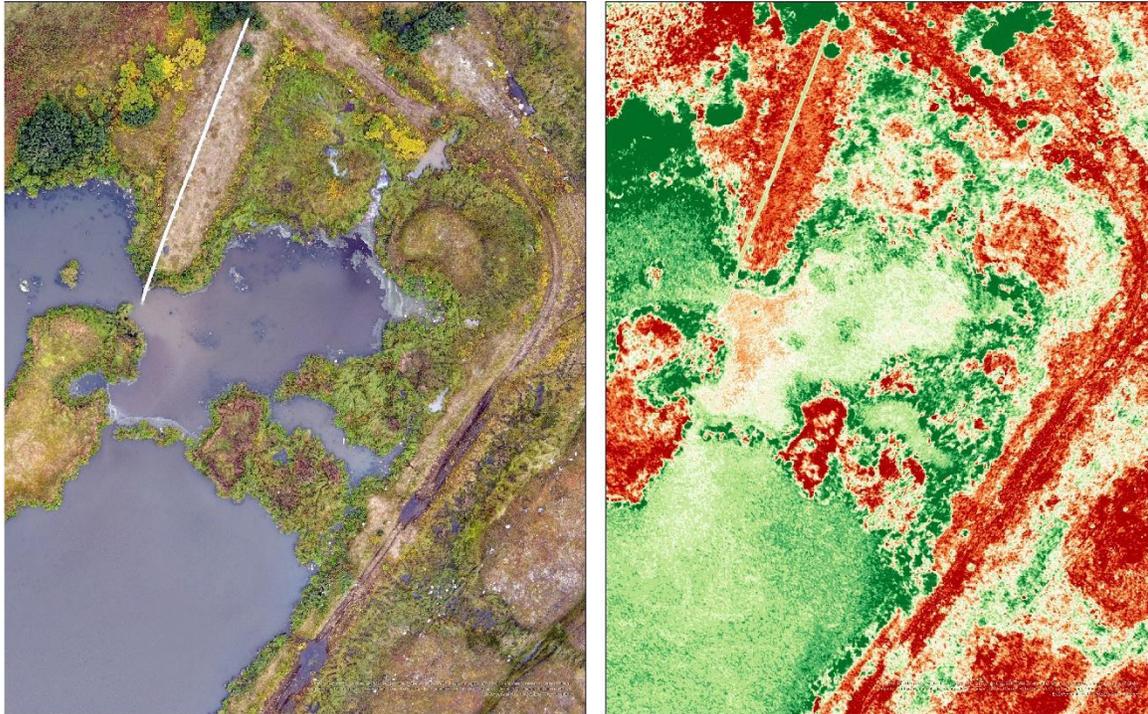
Figure 6 is a closer look at the input pipe. By looking at the color of the water we can have an idea where the input is draining toward initially. The turbid (or brown) water from the pipe, the input, is initially flowing to the southeast toward the area of concern for drainage. Some is flowing north, but it doesn't look like that flow is draining. The initial sewage input flowing toward the four fingers to the southwest is a concern, because if sewage is leaking before it has spent time processing in the lagoon it could be more hazardous.

Figure 6. A close up of input pipe.

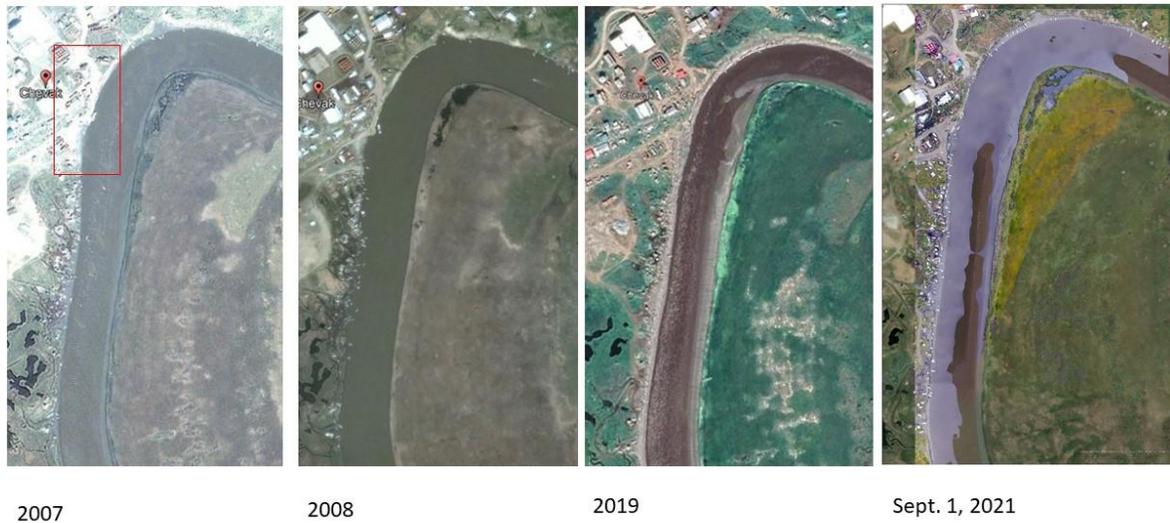
The section of the river flown and mapped using the drone was compared to historic images from 2007, 2008, and 2019 from Google Earth satellite imagery (see Figure 7). A red box marks the area that has eroded during this 14 year period. McKinley St. eroded into the river from 2008 to 2019. It is clear that river erosion has impacted Chevak, and will likely continue to be a concern, given the important community infrastructure located near the area that has experienced the most rapid erosion.

Figure 7. Historic aerial satellite imagery compared to the riverbank mapped in 2021 using the UAS.

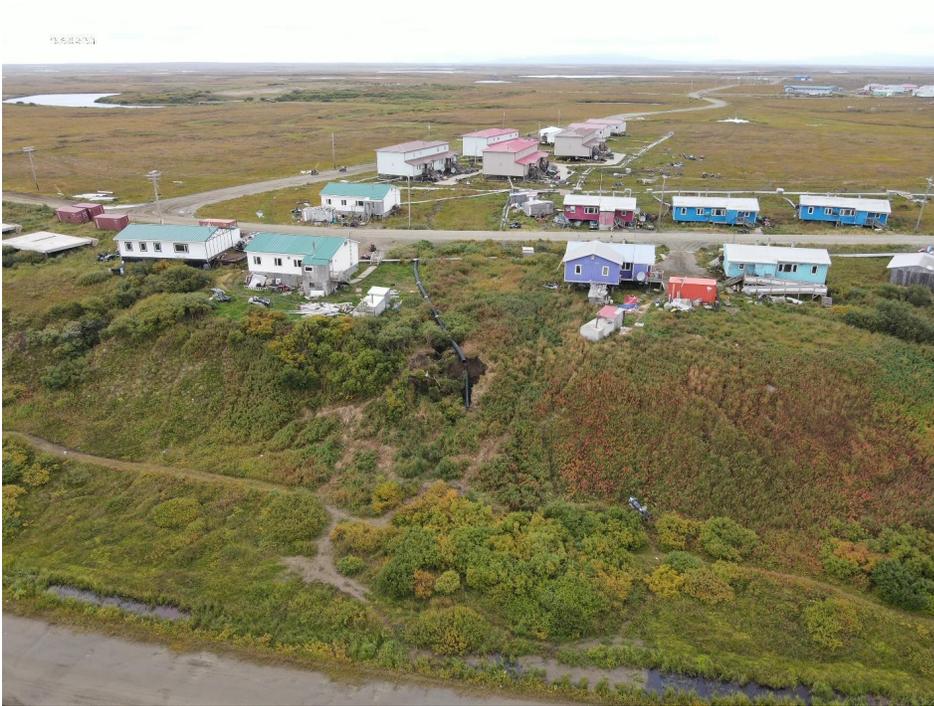
Figures 9 and 10 document an area of concern for erosion. The erosion is happening very near a residential area and threatening homes. Figure 9 documents the erosion and future images can be compared to this one to track the erosion.

Figure 9. Area of concern for erosion near residential areas

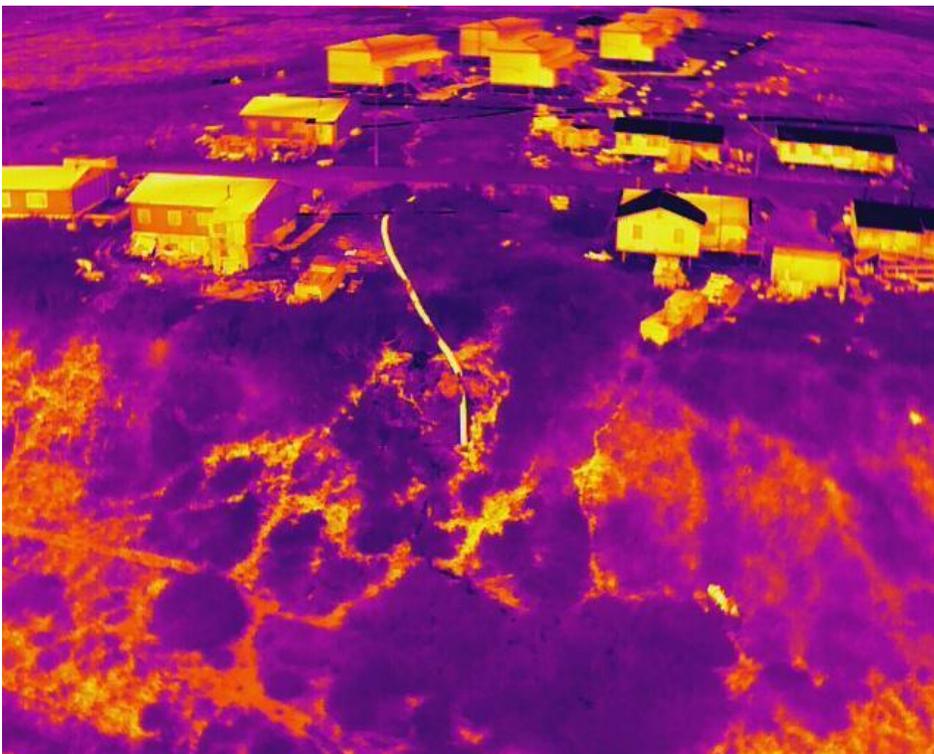
The thermal image (figure 10) was taken on September 1, 2021 at 3:40pm on an overcast day. The sun has warmed the surface. From the thermal imagery you can see how much warmer the black pipe is than the white ones. The warm black pipe could be contributing to melting the ground, although there are likely additional forces of flowing water at work. To try and slow erosion here the black pipe could be wrapped in tin foil or something reflective.

Figure 10. The same image as figure 9 as a thermal image.

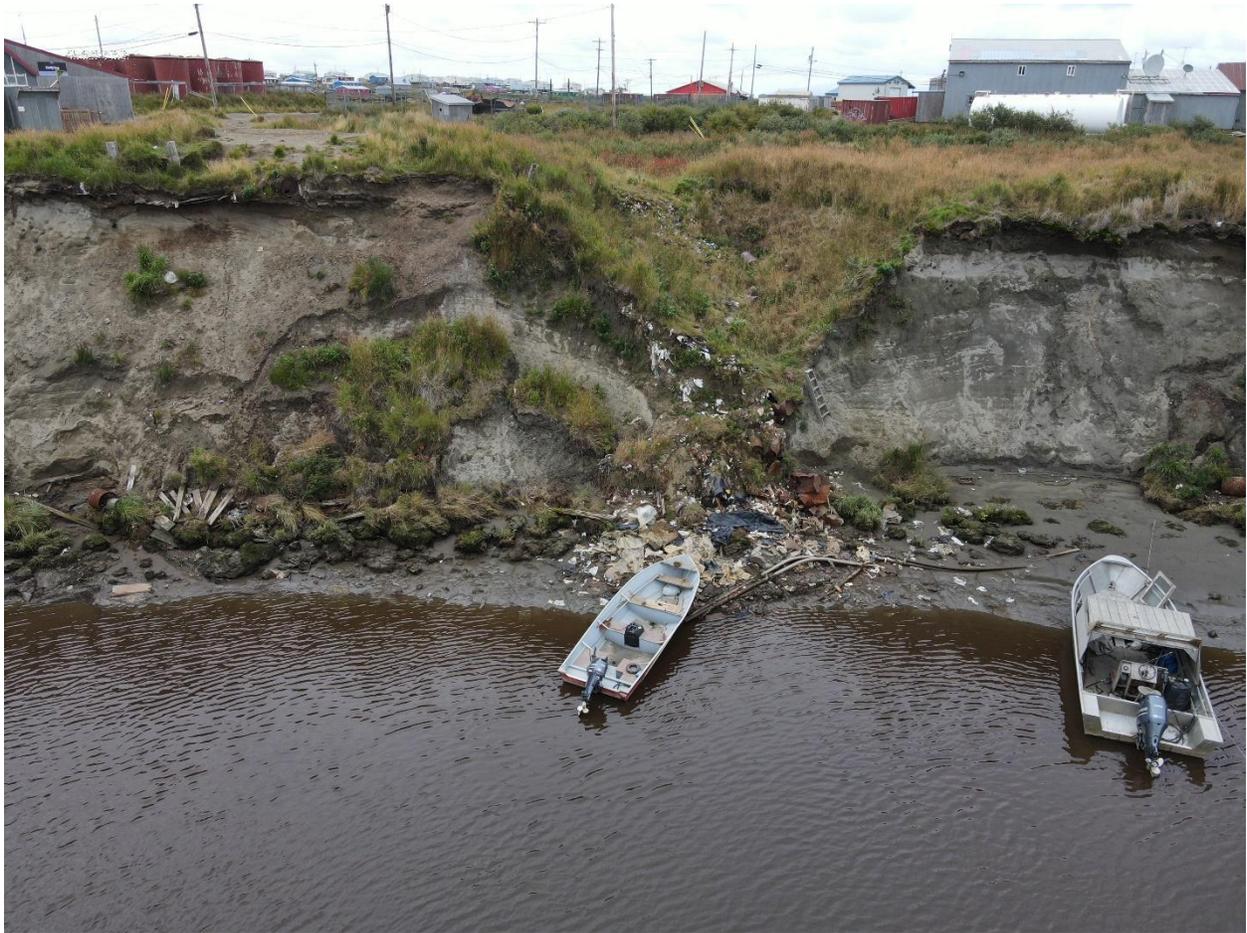
A Brownfield, or potentially contaminated site, was identified by the Tribal Environmental Professionals in Chevak. This site is an illegal dumpsite that was buried until recently, when the river began eroding it away. Figure 11 served as documentation for the addition of this site into our YRITWC Brownfields inventory. This is a first step toward working to have the site assessed and cleaned-up. Clean-up is important so that the contamination doesn't reach the river, or impact human health and safety.

Figure 11. A potentially contaminated site located near where the river is most rapidly eroding.

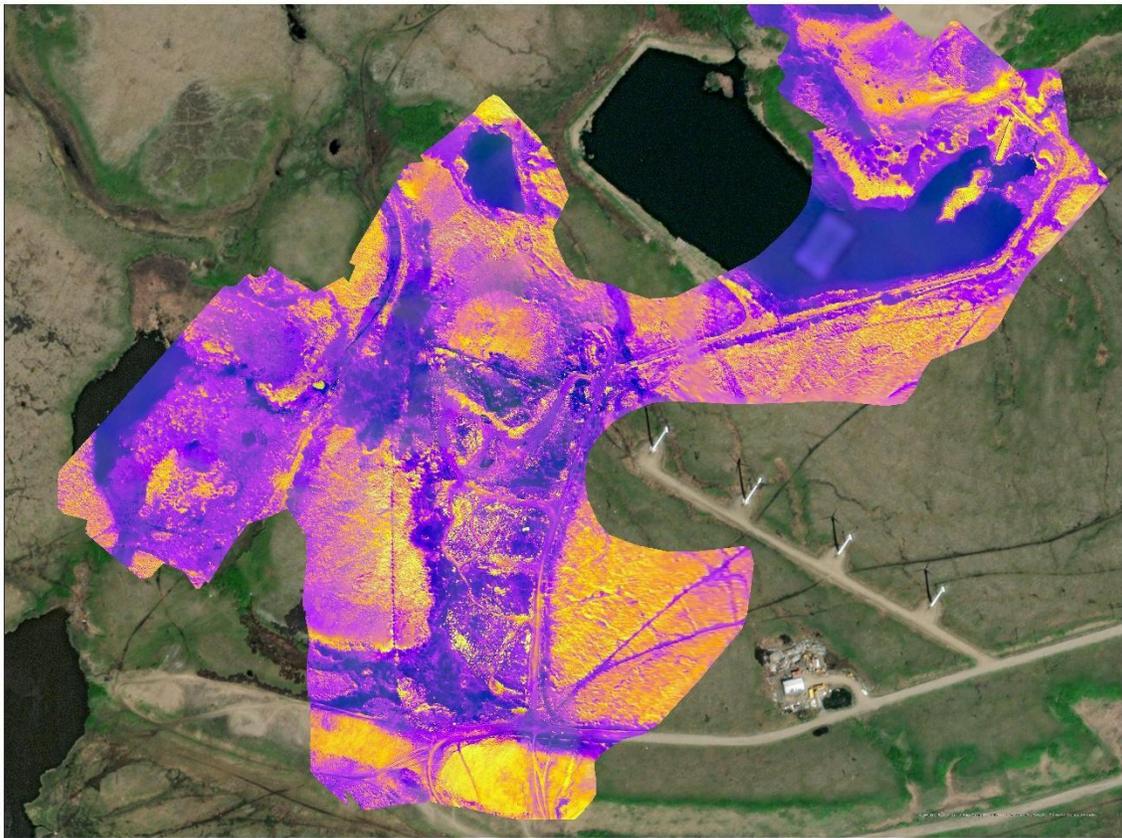
The image in figure 11 was taken on September 1, 2021, at about 2:30pm on a cool, overcast day. The sun's warmth has had some time to warm dry areas. There is an interesting square shape in the lagoon that is causing the water to be a little warmer.

Figure 11. Thermal image of landfill, where blue is cool and yellow is warm.
