**Hydro Vulnerability Assessment
Alakanuk, Alaska
September 2021**

Prepared by the Yukon River Inter-Tribal Watershed Council (YRITWC) in partnership with the Alakanuk Traditional Council. Funding was provided by the BIA Tribal Climate Resilience Program, for the project: *Vulnerability Assessments for Changing Hydrology in Interior Yukon River Basin Communities*. Grant # A19AP00196.

Executive Summary: The YRITWC worked with the Alakanuk Traditional Council's Environmental Department to assess threats related to water, or hydro-vulnerabilities in Alakanuk. This is not a comprehensive document, but includes what we can learn and document by using an Unmanned Aerial System (UAS) in addition to some easily available tools.

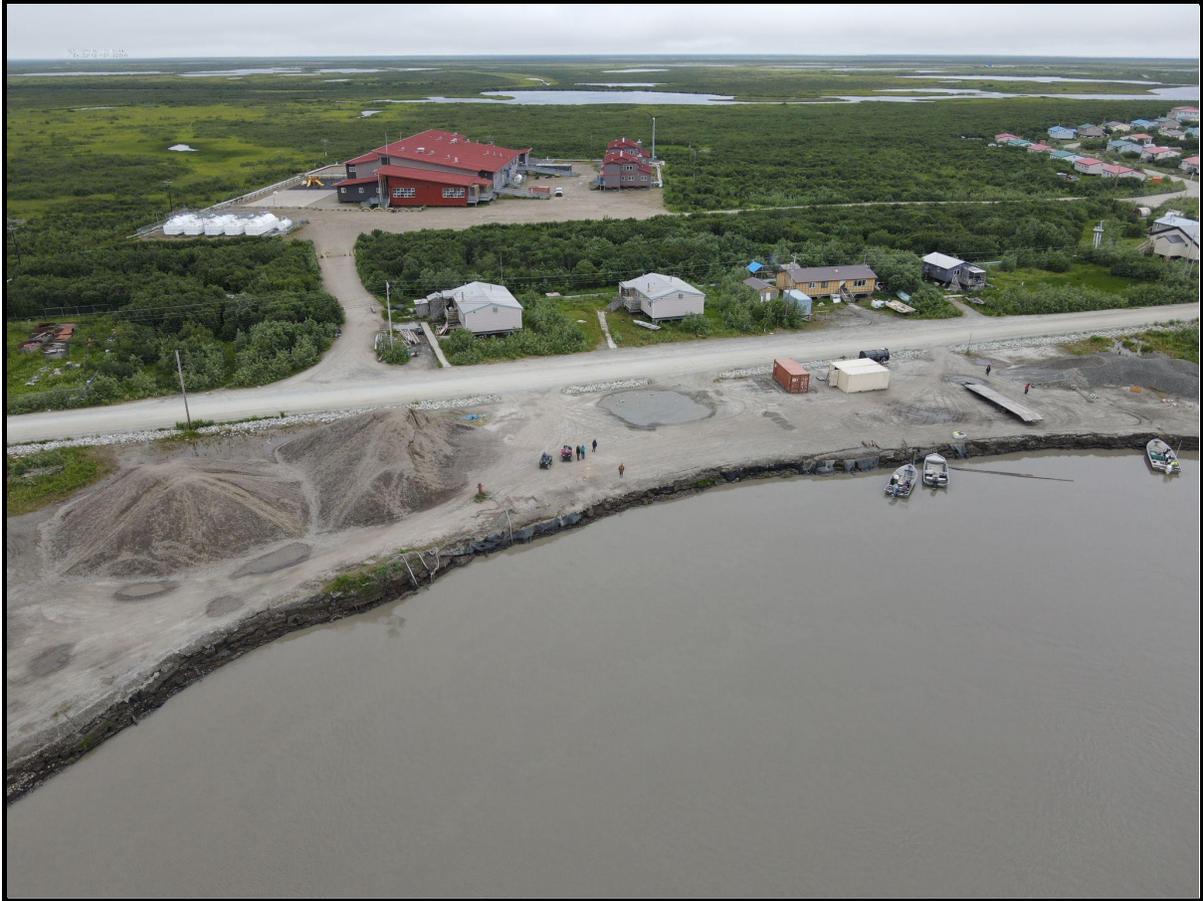
Photo: Alakanuk High School and eroding river bank. Picture taken with a UAS (drone).

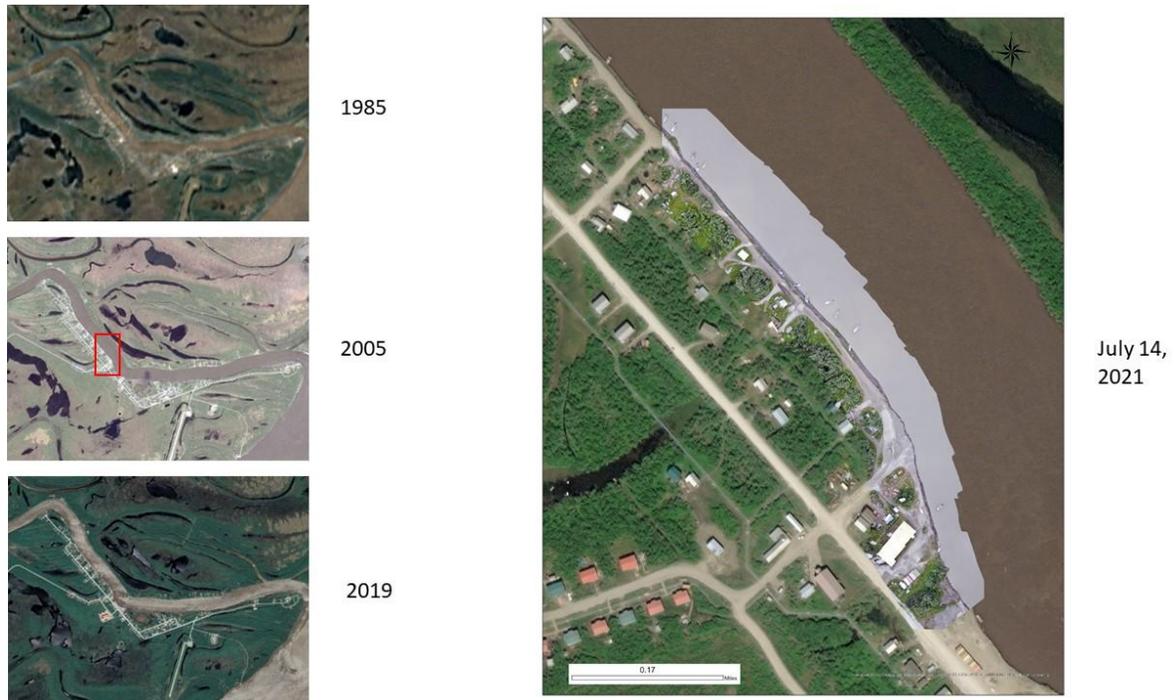
An area of concern for river bank erosion was flown and mapped with a UAS and compared to historical satellite imagery from GoogleEarth (figure 1). In this stretch of river water levels go up and down with the tide, and with seasonal river fluctuations, but in the aerial images changes to the river bank can be seen. Figures 2 - 5 document some of the community assets that are at risk from continued river bank erosion.

Figure 1. Documentation of river bank erosion.

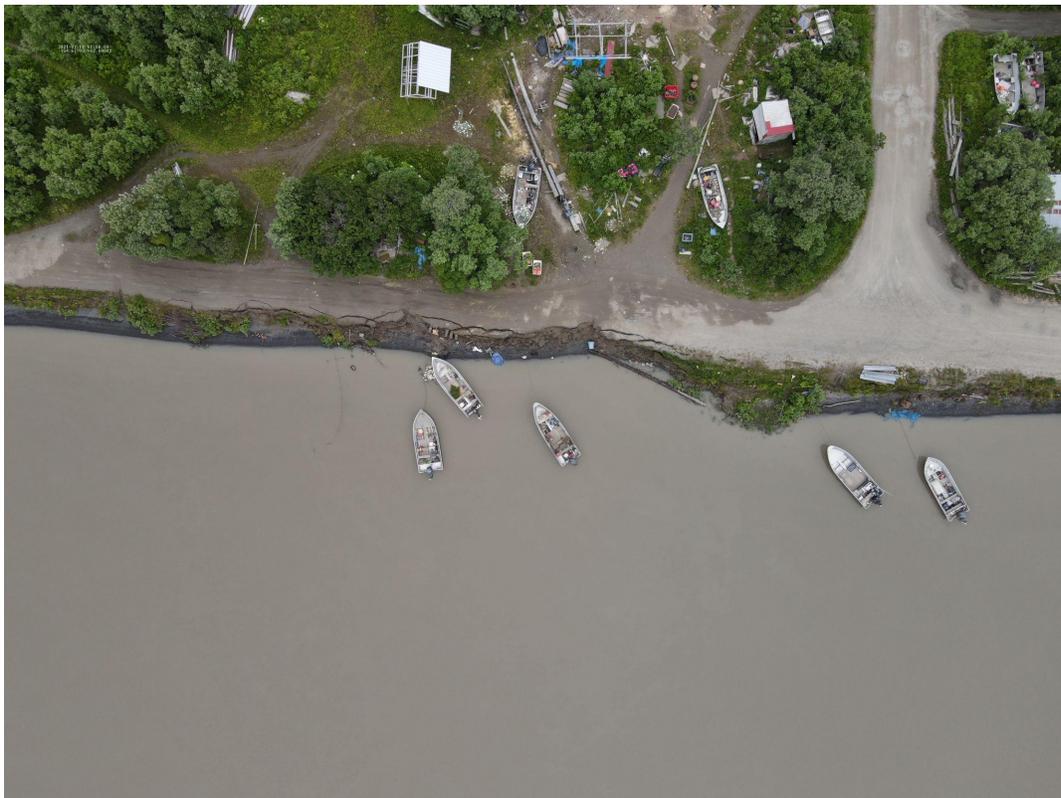
Figure 2. Erosion at boat landing and access road. Active erosion is apparent in the cracks in the road.

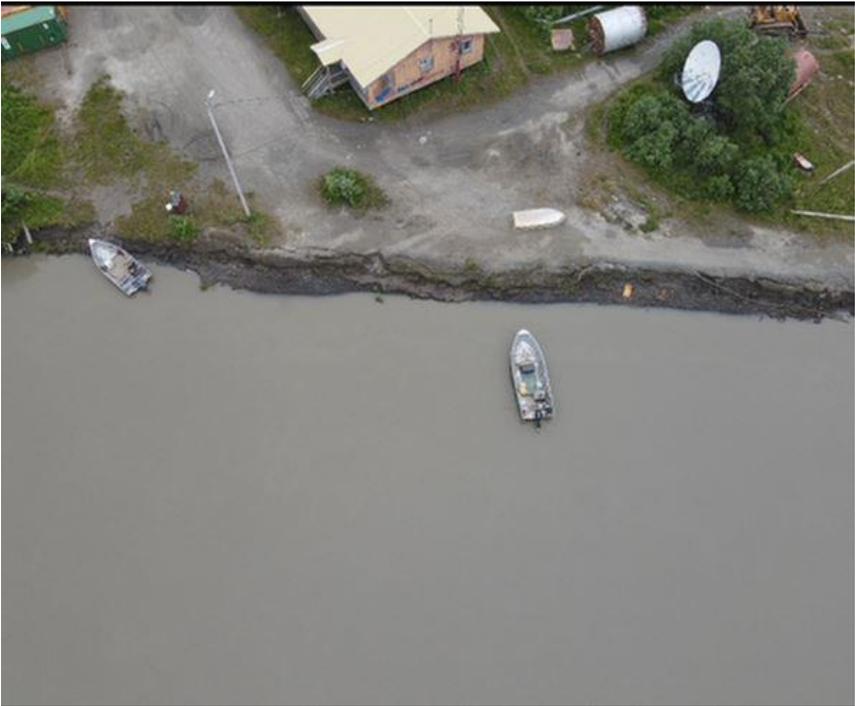
Figure 3. Electrical wire just a few feet from the eroding river bank.

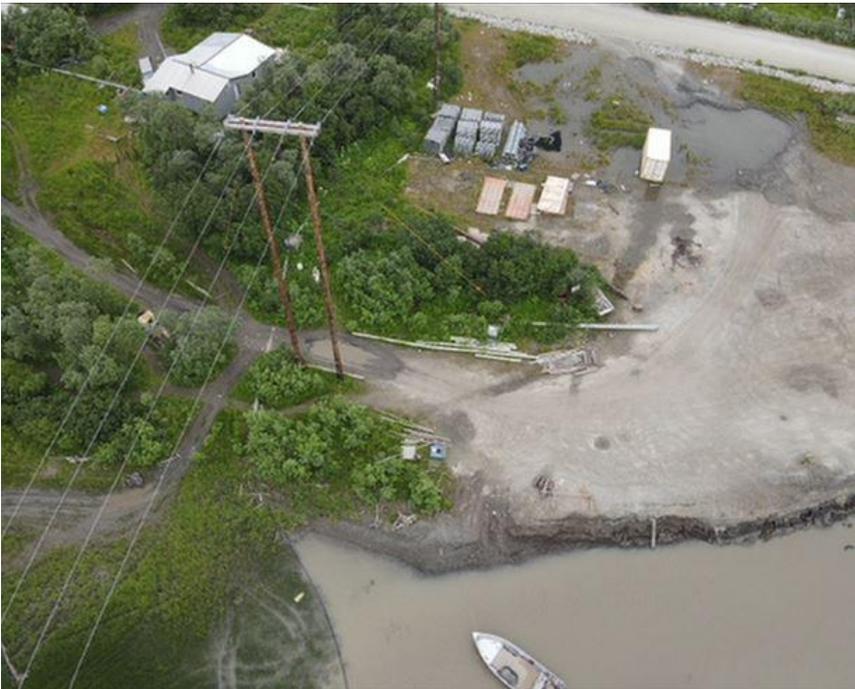
Figure 4. A main electrical wire that connects the community is at risk from erosion.

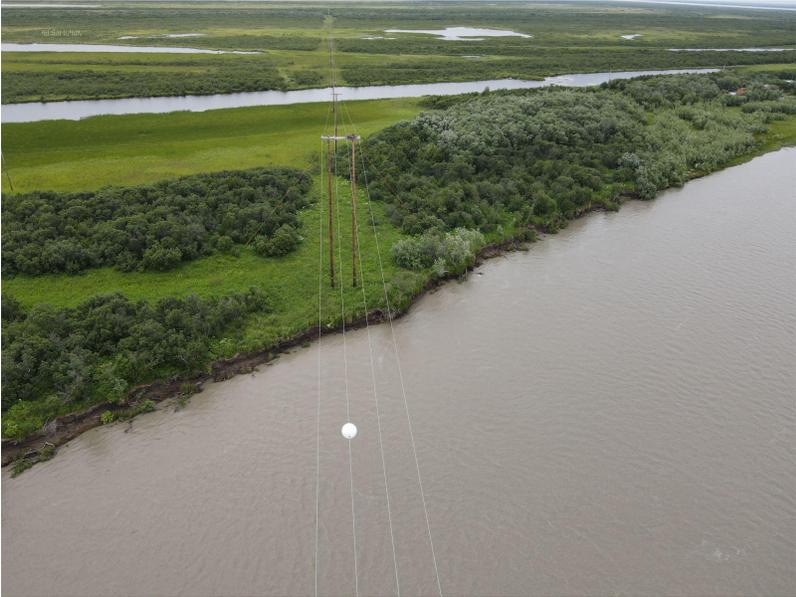
Figure 5. View of main electrical wire that serves the community looking at the other side of the river.

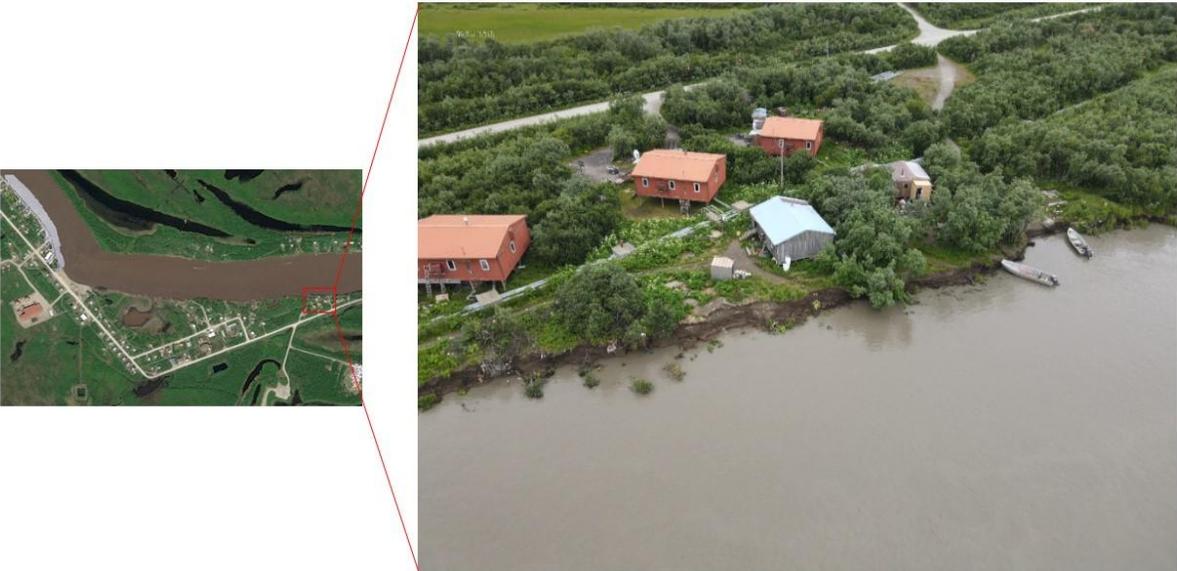
Figure 6. Residences near a rapidly eroding river bank.

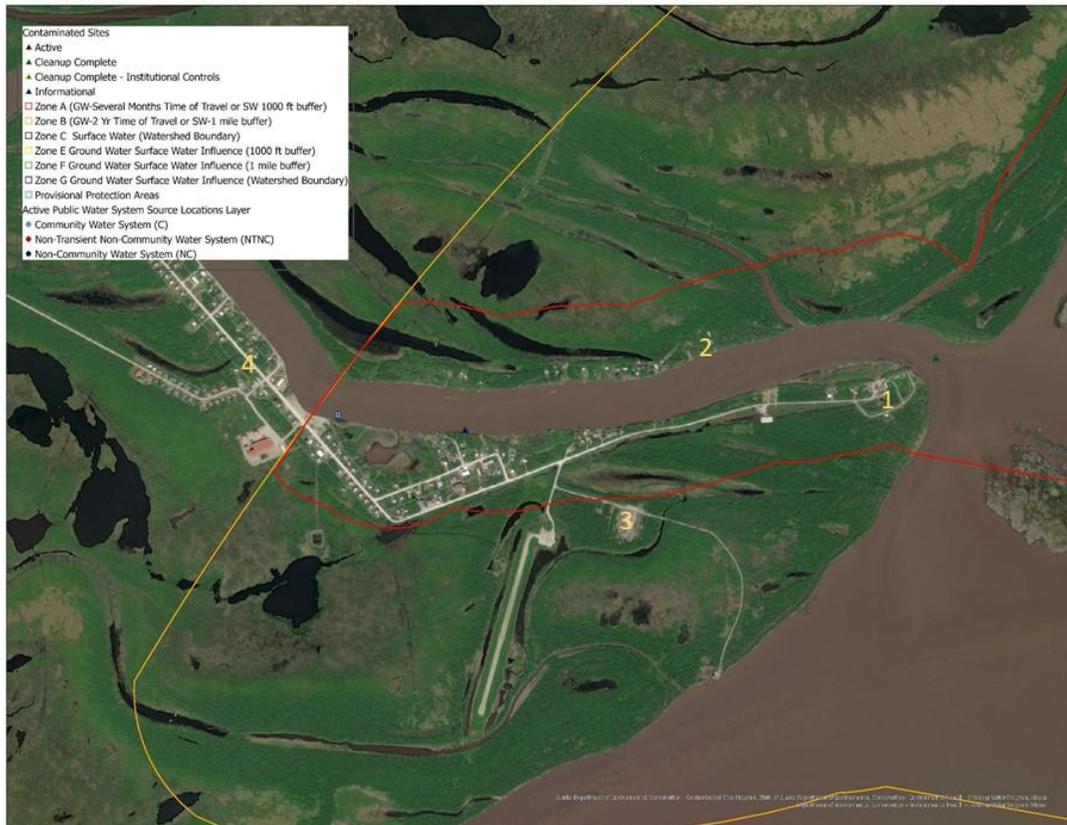
Figure 7 shows the locations of contaminated sites in relation to the drinking water intake, and drinking water protection zones. Drinking water in Alakanuk comes from the surface waters of the river, as such there are two drinking water protections areas. The first is a 1000 foot buffer surrounding waters that feed into the intake (red line), and a 1 mile buffer zone (in orange). It is important to assess contaminated sites within these drinking water protection zones for potential impacts to drinking water.

Figure 7 includes contaminated sites from the AK DEC dataset (marked with triangles) and additional potentially contaminated sites that were documented by YRITWC and Alakanuk's Environmental Department during this project (yellow numbers). Sites from AK DEC include the fuel spill at the Alakanuk power plant that was cleaned-up in 1995¹ and the former South Bank Dumpsite, that YRITWC completed an Environmental Management Plan for in 2011². Structures and tanks were documented at the Old Native Store (#1 in yellow, figures 8-10). Great progress toward clean-up was documented at the Old BIA School North Bank, which is an inventoried site in YRITWC's Brownfield database (#2 in yellow, figure 11). The Scrapyard was documented (#3 yellow, figure 12) for monitoring. This isn't a brownfield site, but a staging area for backhaul, and reuse. Number four in yellow is the Boneyard (figures 13-14) which is in the process of being assessed through an EPA Brownfields Community-wide Assessment grant.

Except for the Boneyard, these potentially contaminated sites fall within a drinking water protection zone. Assessment and clean-up of these sites is important to protect clean water.

Figure 7. Map of potentially contaminated sites in relation to drinking water intake, and drinking water protection zones.

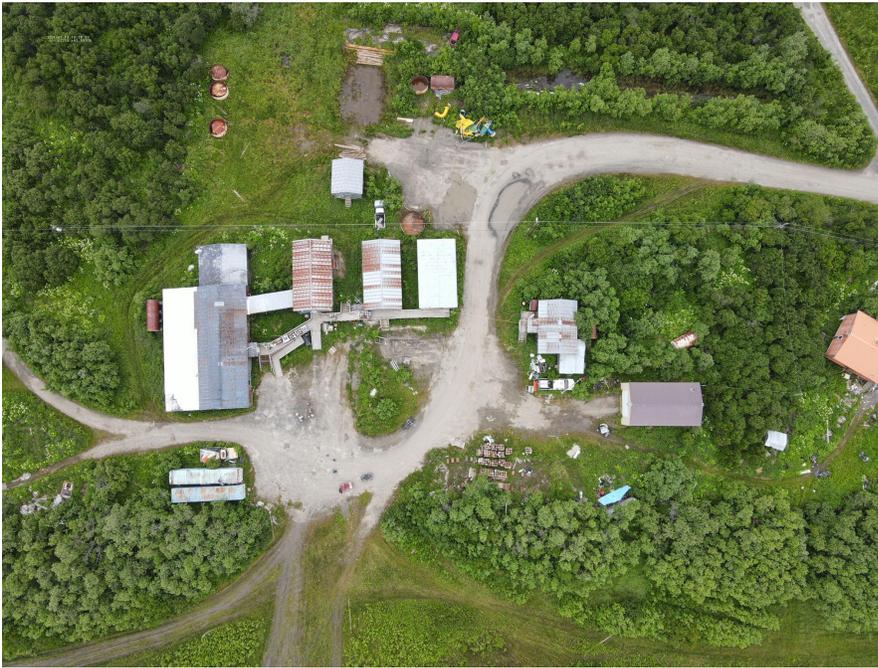
Figure 8. The Old Native Store. The location is marked by a yellow #1 in figure 8.

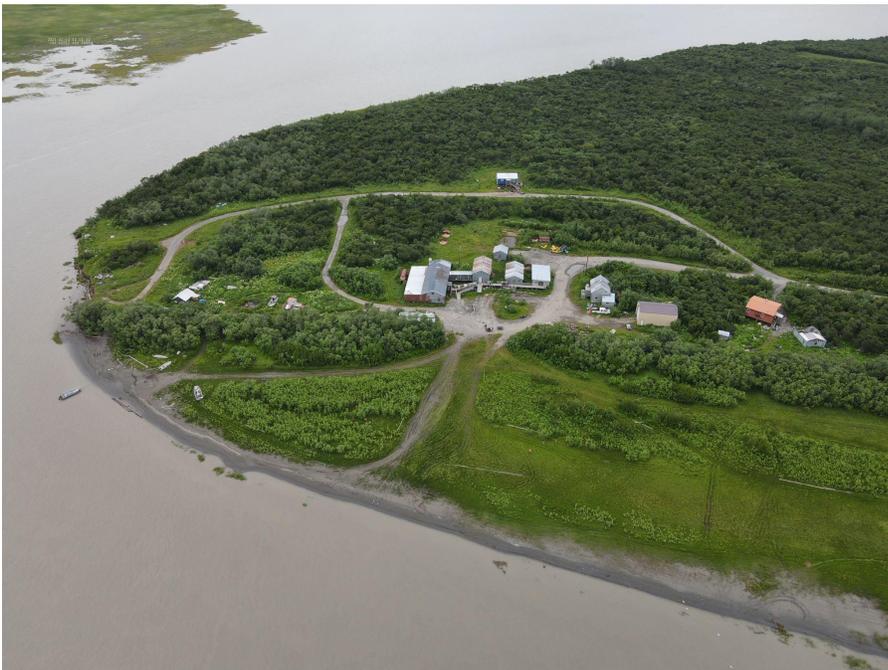
Figure 9. A different view of the Old Native Store, showing its proximity to water.

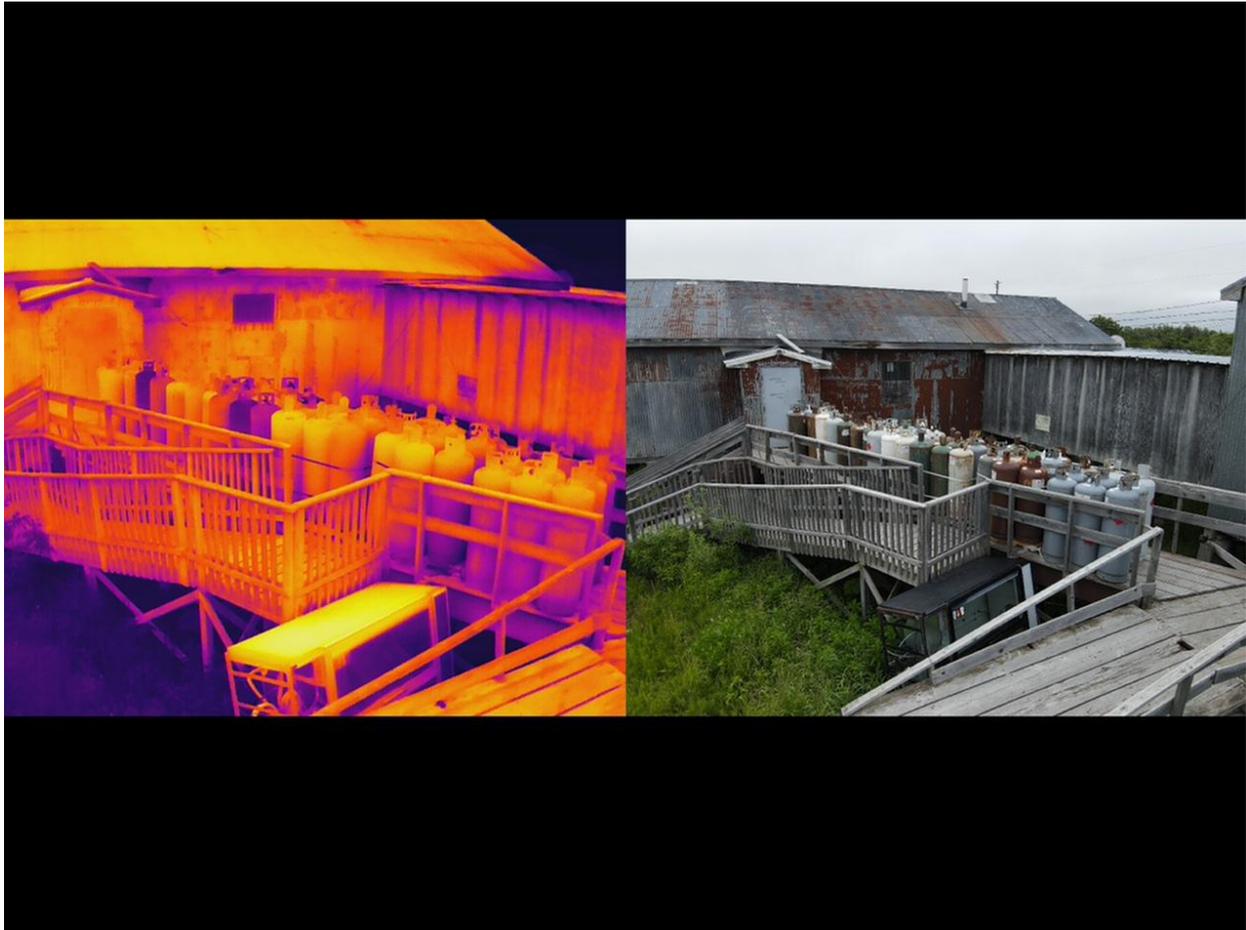
Figure 10. A close-up with an infrared sensor of the propane tanks in front of the Old Native Store. If the tanks contained liquid there would be a clear line on the infrared imagery. The tanks do display different temperatures, which is due to the color of the tanks (dark colored tanks absorb more heat, while lighter tanks reflect it), but since there is no line they are likely empty. This was verified by tapping and lifting a few of the tanks.

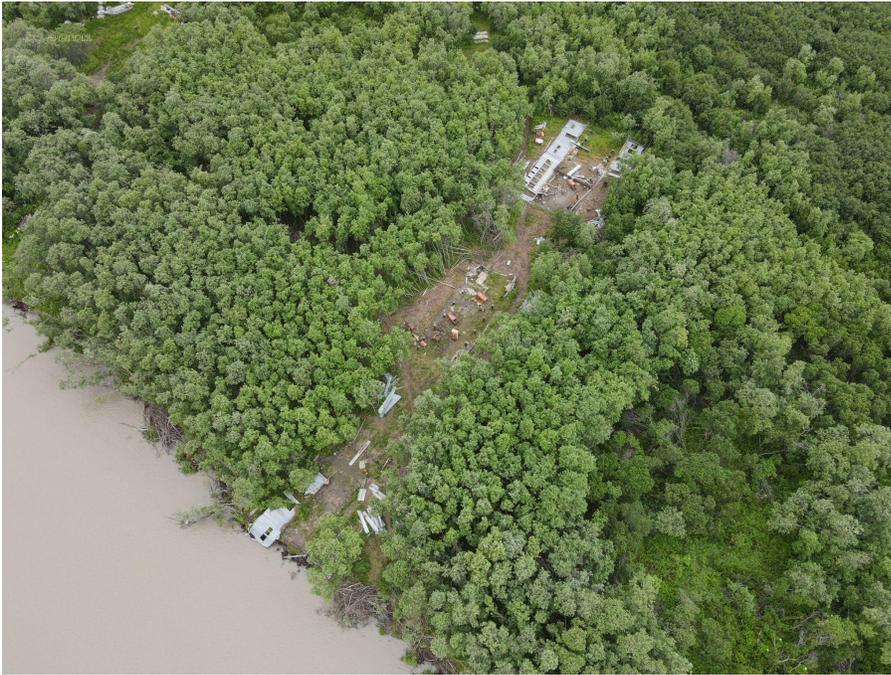
Figure 11. The Old BIA School North Bank Brownfield site in the process of being cleaned-up. Marked by a yellow #2 on figure 7.

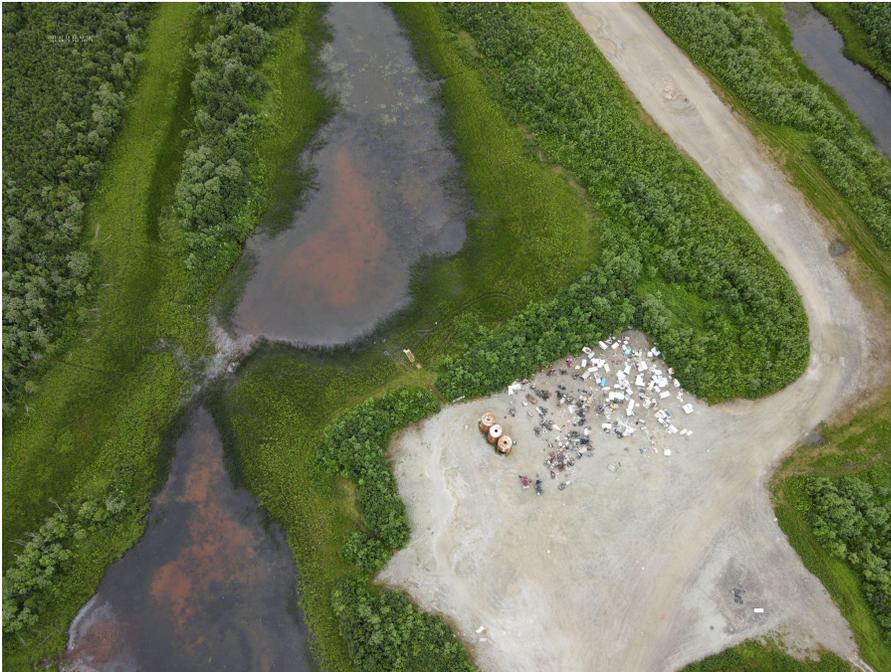
Figure 12. The Scrapyard, marked on figure 7 with a yellow #3. The photo was taken to monitor the site and examine near-by waters.

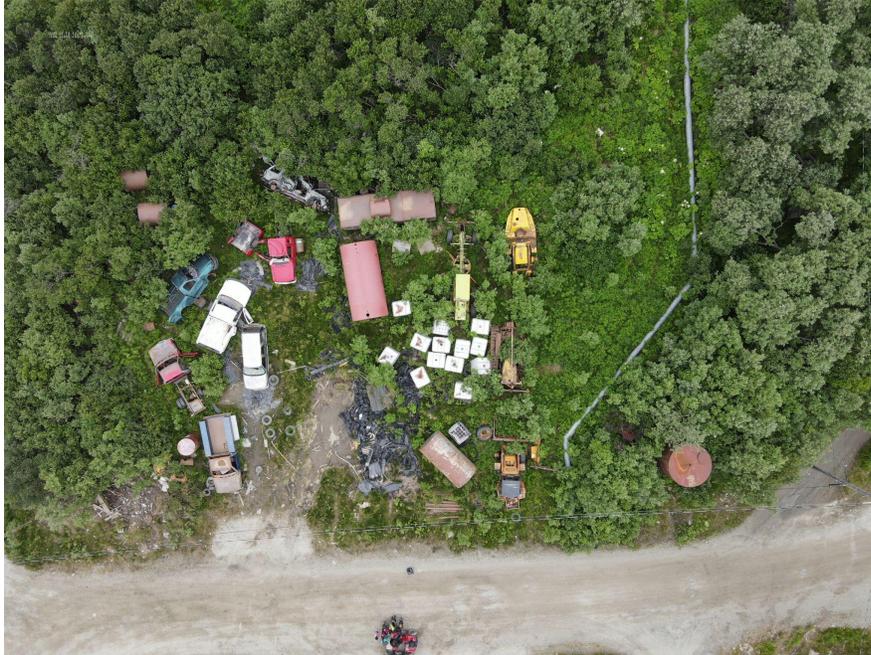
Figure 13. The Boneyard, marked by a yellow #4 on figure 7. Assessment and planning for clean-up will occur in 2022-23.

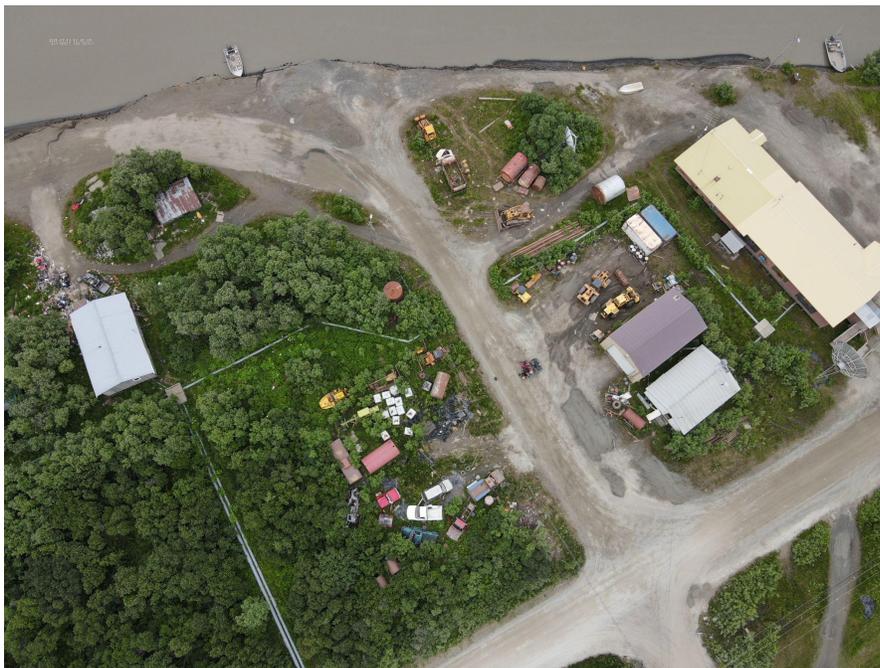
Figure 14. Another view of the Boneyard, showing the proximity to the river.

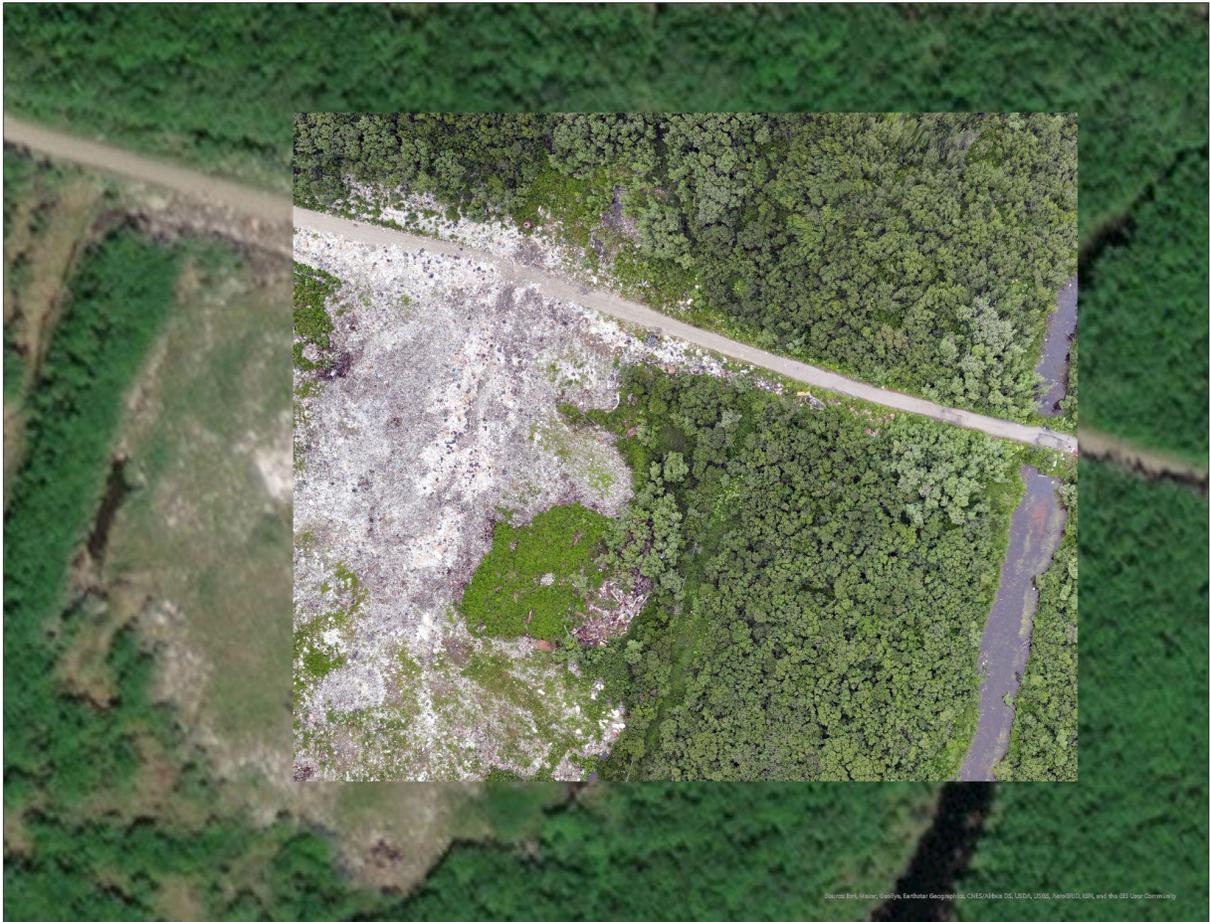
Aerial photos were taken of the landfill in Alakanuk for monitoring purposes, and to look for any obvious impacts to nearby waters. The DroneDeploy software stitches aerial images together to make an orthomosaic aerial map, which has been mathematically corrected to represent an accurate view of the area. Unfortunately, not enough photos were taken of the west side of the landfill for a complete map of the landfill. Figure 15 shows the portion of the landfill that was successfully mapped. Figure 16 shows the elevation map and NDVI (or vegetation health) map that were examined for impacts to water. Since the elevation map is an incomplete view of the landfill it is difficult to know which direction surface waters flow. There are no patterns in the NDVI map that could indicate leachate flow. Continued monitoring of the landfill will help identify issues, and help to target areas that need attention. An additional flight with more pictures would contribute to understanding overland flow of waters.

Figure 15. Orthomosaic map of a portion of the Alakanuk landfill.

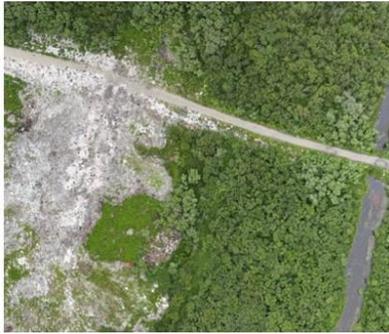
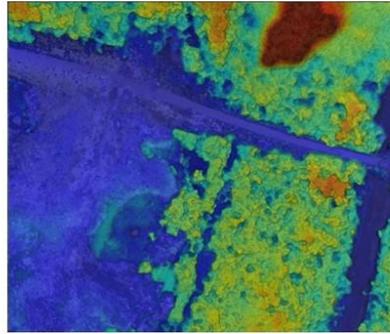
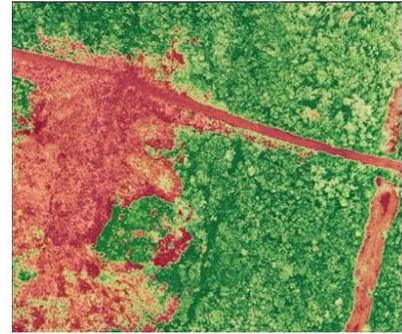
Figure 16. Aerial imagery including a Red, Green, Blue image, an elevation map and an NDVI map were examined for impacts to nearby waters.

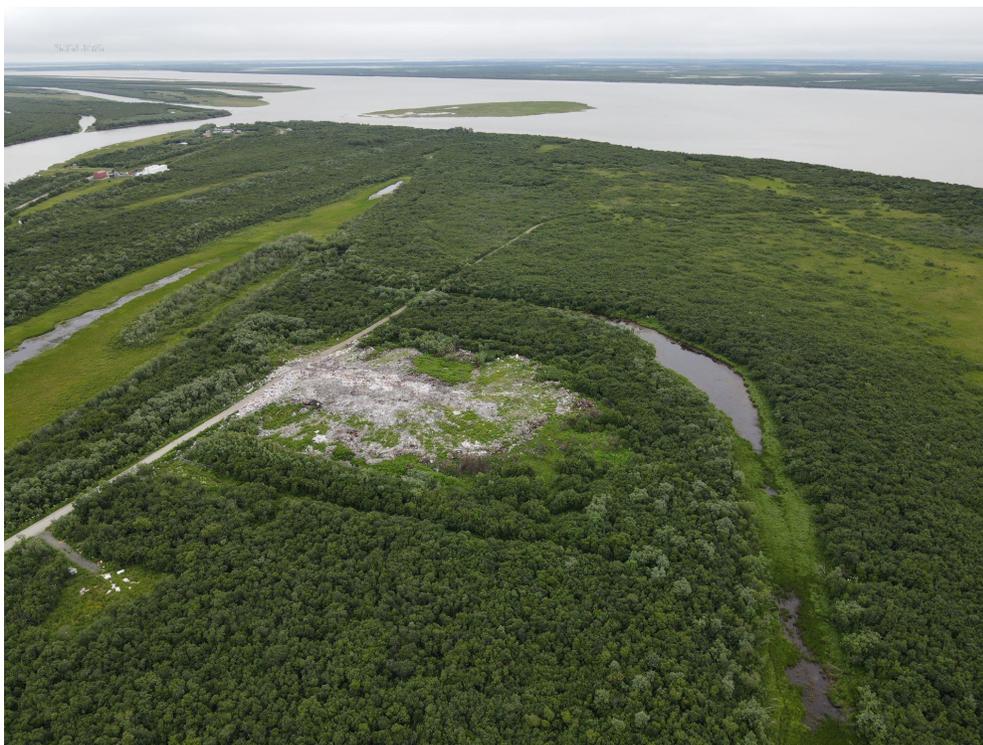
Figure 17. A complete view of the landfill showing surrounding waters taken from west of the landfill.

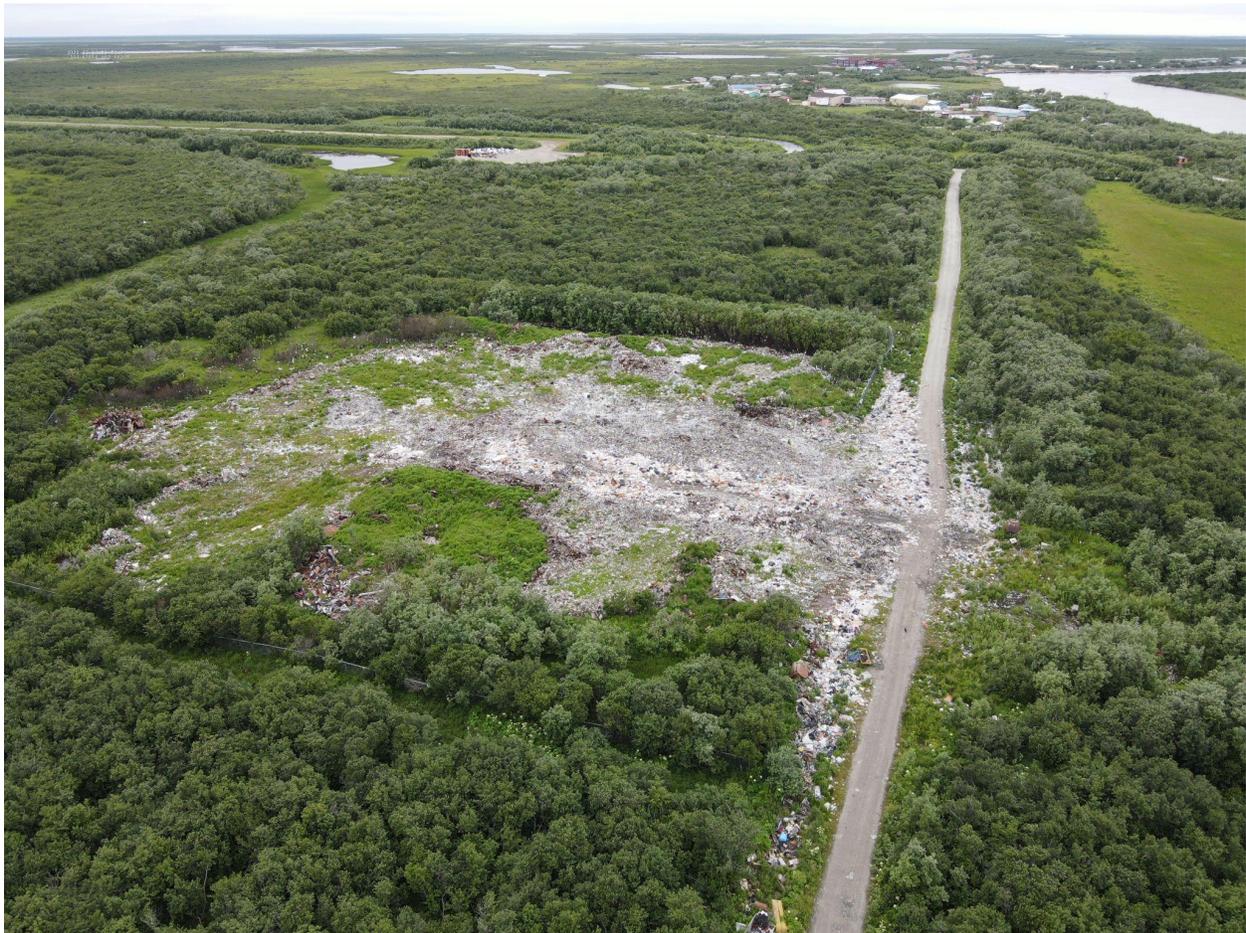
Figure 18. A complete view of the landfill taken from the east looking toward the village.
