Hydro-Vulnerability Assessment

Chevak, Alaska

September 2021

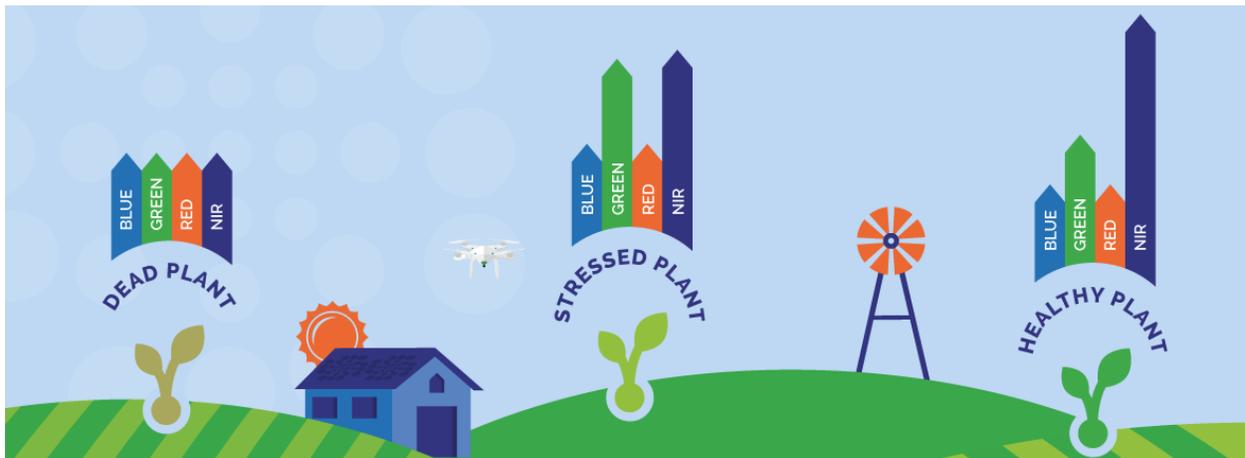
In figure 5 red indicates unhealthy or dead vegetation (red is dead) while darker green denotes photosynthetic activity and healthy vibrant plants. Plants need nitrogen, phosphorus and potassium to grow. Sewage lagoons are rich in nitrogen and phosphorus (similar to fertilizers). So more sewage will cause plants to be greener. The two map panels on the right are a close up of the area of concern. There

are four main 'fingers' where plants are very healthy. In addition, from the aerial imagery and from on-the-ground investigations, we can see these areas are wet. This provides more evidence that the lagoon is leaking out of the eastern side.

Figure 5. Vegetation stress map.
